Final Report

Water Line Leak Detection Project for: City of Cannon Beach, OR

Project Dates:
02/05/2018 through 02/07/2018

Re: February 2018 Water Distribution System Leak Detection Project

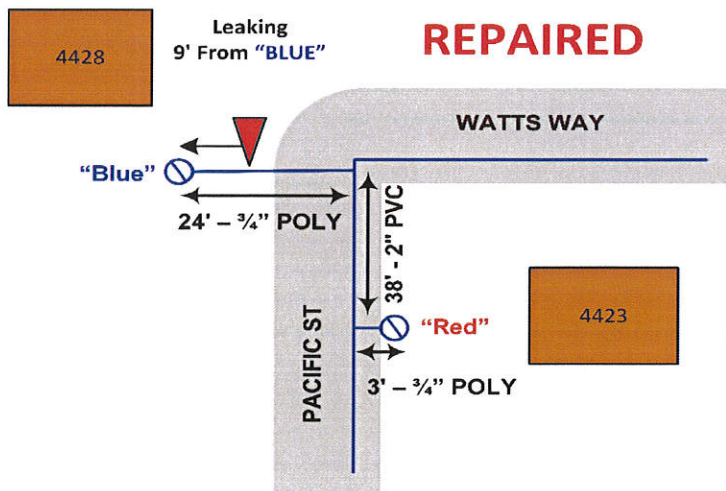
Leak #:	2
Date:	February 6, 2018
Map #:	
Lat:	
Long:

EXCELLENT LEAK NOISE DETECTED ON METER. ONE LOW QUALITY CORRELATION POINTS 8 FEET FROM METER. EXCELLENT GROUND MICROPHONE NOISE DETECTED 9 FEET FROM METER. THERE IS ALSO GROUND MICROPHONE NOISE DETECTED NEAR THE SERVICE CONNECTION AREA OR 90 DEGREE BEND. THE EXACT LOCATION OF SERVICE IS UNKNOWN BUT MOST LIKELY CLOSE TO 90 DEGREE BEND. THE NOISE DETECTED NEAR 90 DEGREE BEND OR SERVICE CONNECTION COULD BE TURBULENCE FEEDING THE LEAK ON THE SERVICE LINE.

Leak Consultant:	TO
Leak Class:	II
Leak Rate (GPM):	20
Cover Type:	GRAVEL
Site Marked:	YES
Mins. Pinpointing:	60

Action(s) Taken: LEAK REPAIRED
 Recommendation(s): EXCAVATE & REPAIR

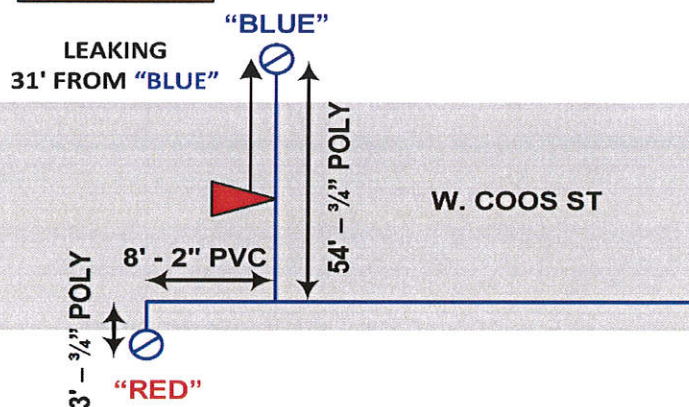
Leak #:	3
Date:	February 7, 2018
Map #:	
Lat:	
Long:

ONE CORRELATION 31 FEET FROM METER. EXCELLENT CONFIRMATION WITH GROUND MICROPHONE.

Leak Consultant:	TO
Leak Class:	II
Leak Rate (GPM):	20
Cover Type:	GRAVEL
Site Marked:	YES
Mins. Pinpointing:	60

Action(s) Taken: LEAK REPAIRED
 Recommendation(s): EXCAVATE & REPAIR

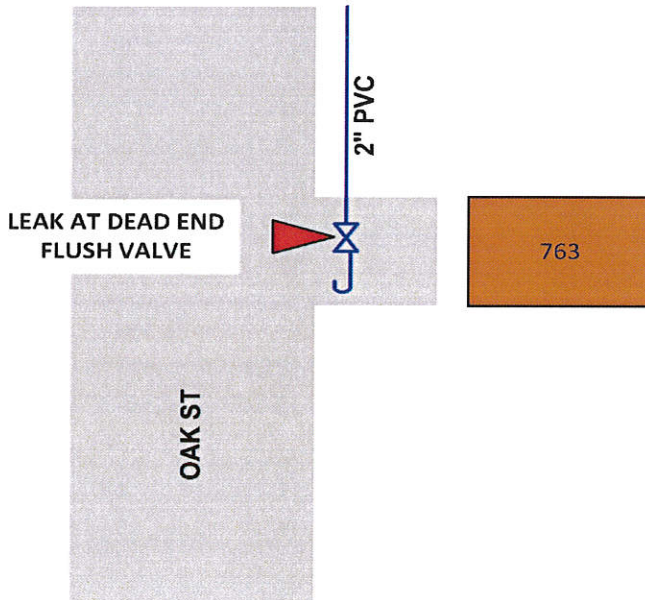
Leak #:	4
Date:	February 7, 2018
Map #:	
Lat:	
Long:

LEAK NOISE DETECTED ON DEAD END FLUSH VALVE. CITY OF CANNON BEACH STAFF OPERATED VALVE SLIGHTLY AND NOISE OF LEAK CHANGED. LEAK IS PASSING THROUGH DEAD END FLUSH VALVE OR ASSOCIATED WITH THE VALVE CONNECTION OR PACKING.

Leak Consultant:	TO
Leak Class:	III
Leak Rate (GPM):	0.1
Cover Type:	ASPHALT
Site Marked:	NO
Mins. Pinpointing:	20

Action(s) Taken: ISOLATED TO ELIMINATE FLOW
 Recommendation(s): REPAIR / REPLACE

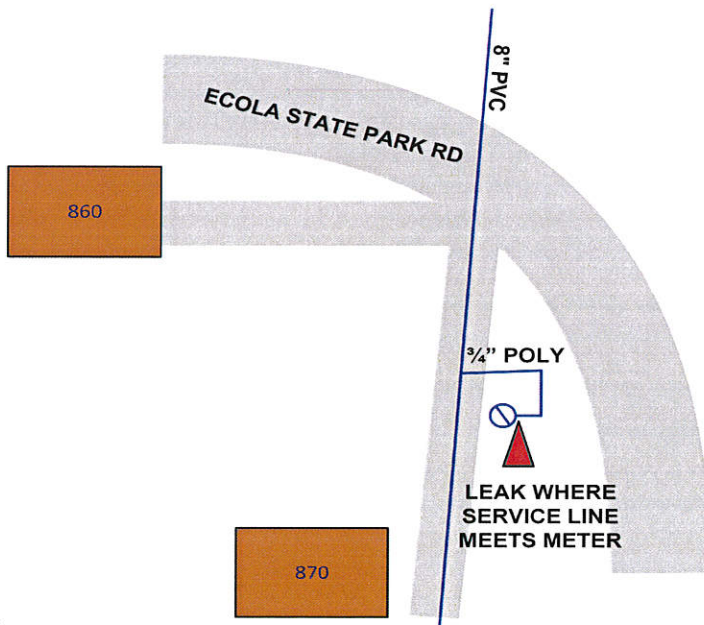
Leak #:	5
Date:	February 7, 2018
Map #:	
Lat:	
Long:

VISIBLE WATER MOVING IN METER BOX. LEAK MAY BE AT SERVICE LINE/SETTER CONNECTION.

Leak Consultant:	TO
Leak Class:	III
Leak Rate (GPM):	0.25
Cover Type:	SOIL
Site Marked:	NO
Mins. Pinpointing:	20

Recommendation(s): REPAIR / REPLACE

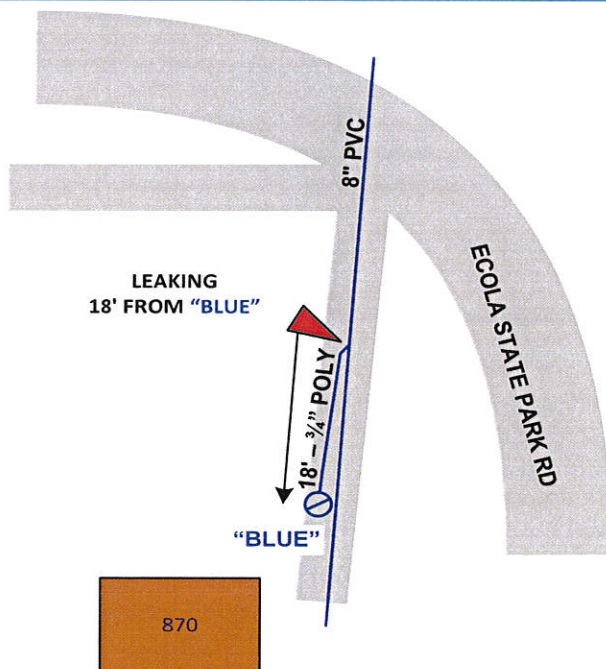
Leak #:	6
Date:	February 7, 2018
Map #:	
Lat:	
Long:

LEAK NOISE DETECTED ON METER. LEAK WOULD NOT CORRELATE. LEAK WAS LOCATED WITH GROUND MICROPHONE AND PROBE 18 FEET FROM METER. SERVICE LINE MAP SHOWS 17 1/2 FEET OF SERVICE LINE.

Leak Consultant:	TO
Leak Class:	II
Leak Rate (GPM):	10
Cover Type:	GRAVEL
Site Marked:	YES
Mins. Pinpointing:	45

Recommendation(s): EXCAVATE & REPAIR
