Subject: Geotechnical Investigation and Geologic Hazard Report

Proposed Forest Lawn 3-Lot Partition
Clatsop County Tax Lot No. 51030DA04100

Cannon Beach, Clatsop County, Oregon

EEI Report No. 22-103-1-R1

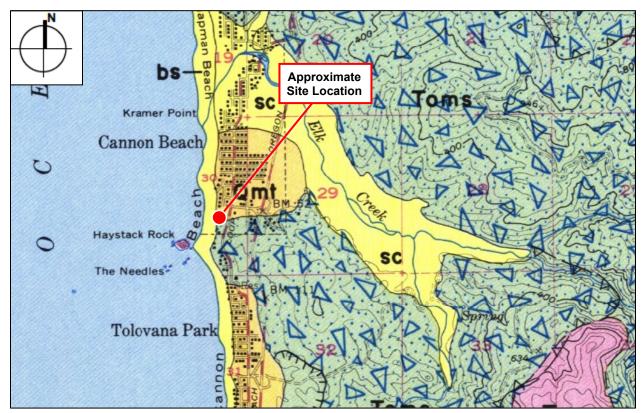
In addition, Schlicker and others (1972)³ indicates that the subject property is mapped adjacent to an active landslide area. Active landslide areas are described as "areas where ground movement is continuous or periodic or areas in which historic movement has taken place. The area includes debris and rockfalls on the headlands, shallow slump failures along terraces fronting the ocean and bays, and areas of local slump in upland areas". The underlying bedrock unit in

Figure 4: Geologic map of the area; the blue triangle pattern is symbolic of landslide topography (base map source: Schlicker and others, 1972).

We did not observe signs of recent or active landslides from our reconnaissance of the immediate area. Based on our observations of exposed and subsurface soils, as well as the geomorphic features of the site and nearby properties, it is our professional opinion that the site is likely at risk from shallow and deep global landsliding.

The upper, roughly 30 to 40 feet of soft soil is at risk of localized shallow landsliding or soil creep. Adding the weight of a home to this soil layer could increase that risk. As such, we recommend that any house foundations be supported on a deep foundation that extends through this soil layer.

The second landslide risk is from deep-seated block failure given the property may be sitting on a relatively deep portion of the landslide debris. Based on our explorations, it is our professional opinion that the sandstone encountered is the stable layer, therefore extending deep foundations through the upper, compressible soils and bearing them on the sandstone will mitigate the risk of deep global landsliding.

In summary, our recommended approach is to employ a deep foundation system that extends through the compressible, organic soils, and protects the house foundations from shallow, localized landsliding or slope creep that might occur in the future.

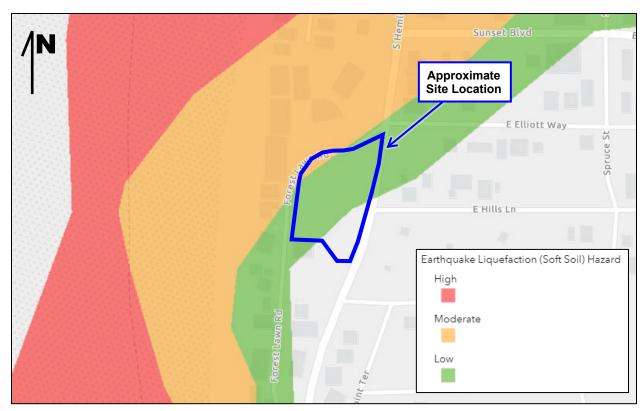
Figure 7: HazVu map showing the liquefaction (soft soil) hazard area.

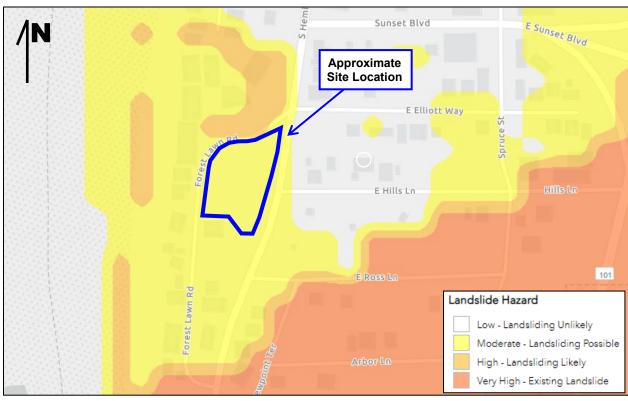
Figure 8: HazVu map showing the landslide hazard zones.

As stated above, the subject property is surrounded by ancient landslides, and is mapped within a moderate landslide hazard area (i.e. landsliding possible). Although the subject property is not mapped within an ancient landslide, the compressible, variable soils we encountered to depths of 30 to 40 feet are consistent with landslide material we have observed in the area. It is very normal/typical for the shallow, compressible soils to slide after wet winter weather or a seismic

event. We do not believe this property is at any greater risk from this hazard than the other numerous existing developed lots in the neighborhood. That being said, we recommend that at a minimum, any house foundations be designed to protect life-safety (i.e. the house is allowed to be damaged by landsliding but the structure stays intact long enough for the occupants to evacuate).

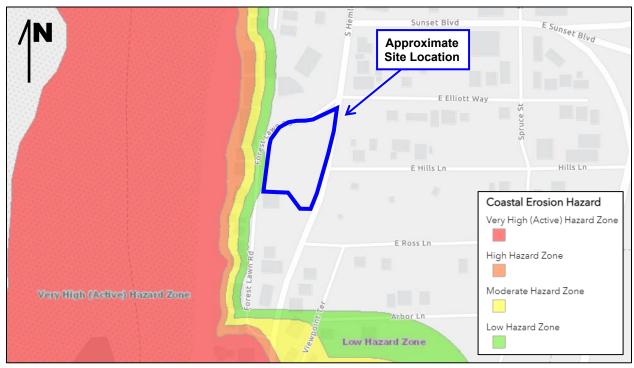
Figure 10: HazVu map showing the mapped coastal erosion hazard.

As shown in Figure 10 above, the western property line is mapped within a low risk of coastal erosion hazard. Although we do not believe that the subject property is at immediate risk from coastal erosion, it could recede back towards the home gradually over time. We envision that it would occur in several sequences that would allow for addressing the issue before it ever reached the house. In addition, any structures would be protected from erosion if supported on a foundation that bears directly on the more stable sandstone stratum (i.e. piles).

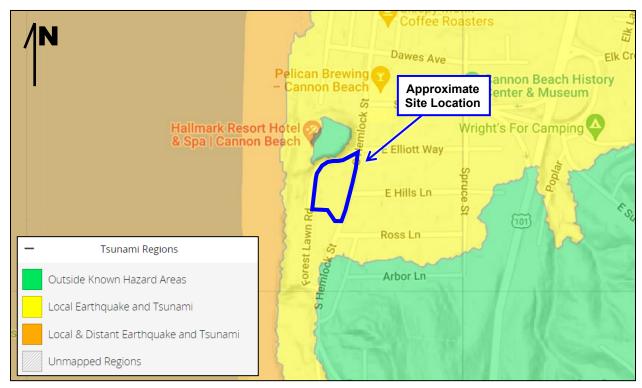
Figure 11: NVS map showing the mapped tsunami hazard region.

As shown in Figure 11 above, the property is at risk of being inundated by a tsunami. We are not providing any geotechnical recommendations for mitigating that risk from tsunami level events. Developing on the lot means that the property owner needs to accept the risk of damage to the residences in the event of a tsunami.
