**S-Curves Landslide Investigation and Stabilization
Cannon Beach, Oregon**

**Geotech
Solutions Inc.**

GSI Project: Cannon-02-01-gi

GEOTECHNICAL ENGINEERING SERVICES S-Curves Landslide Investigation and Stabilization

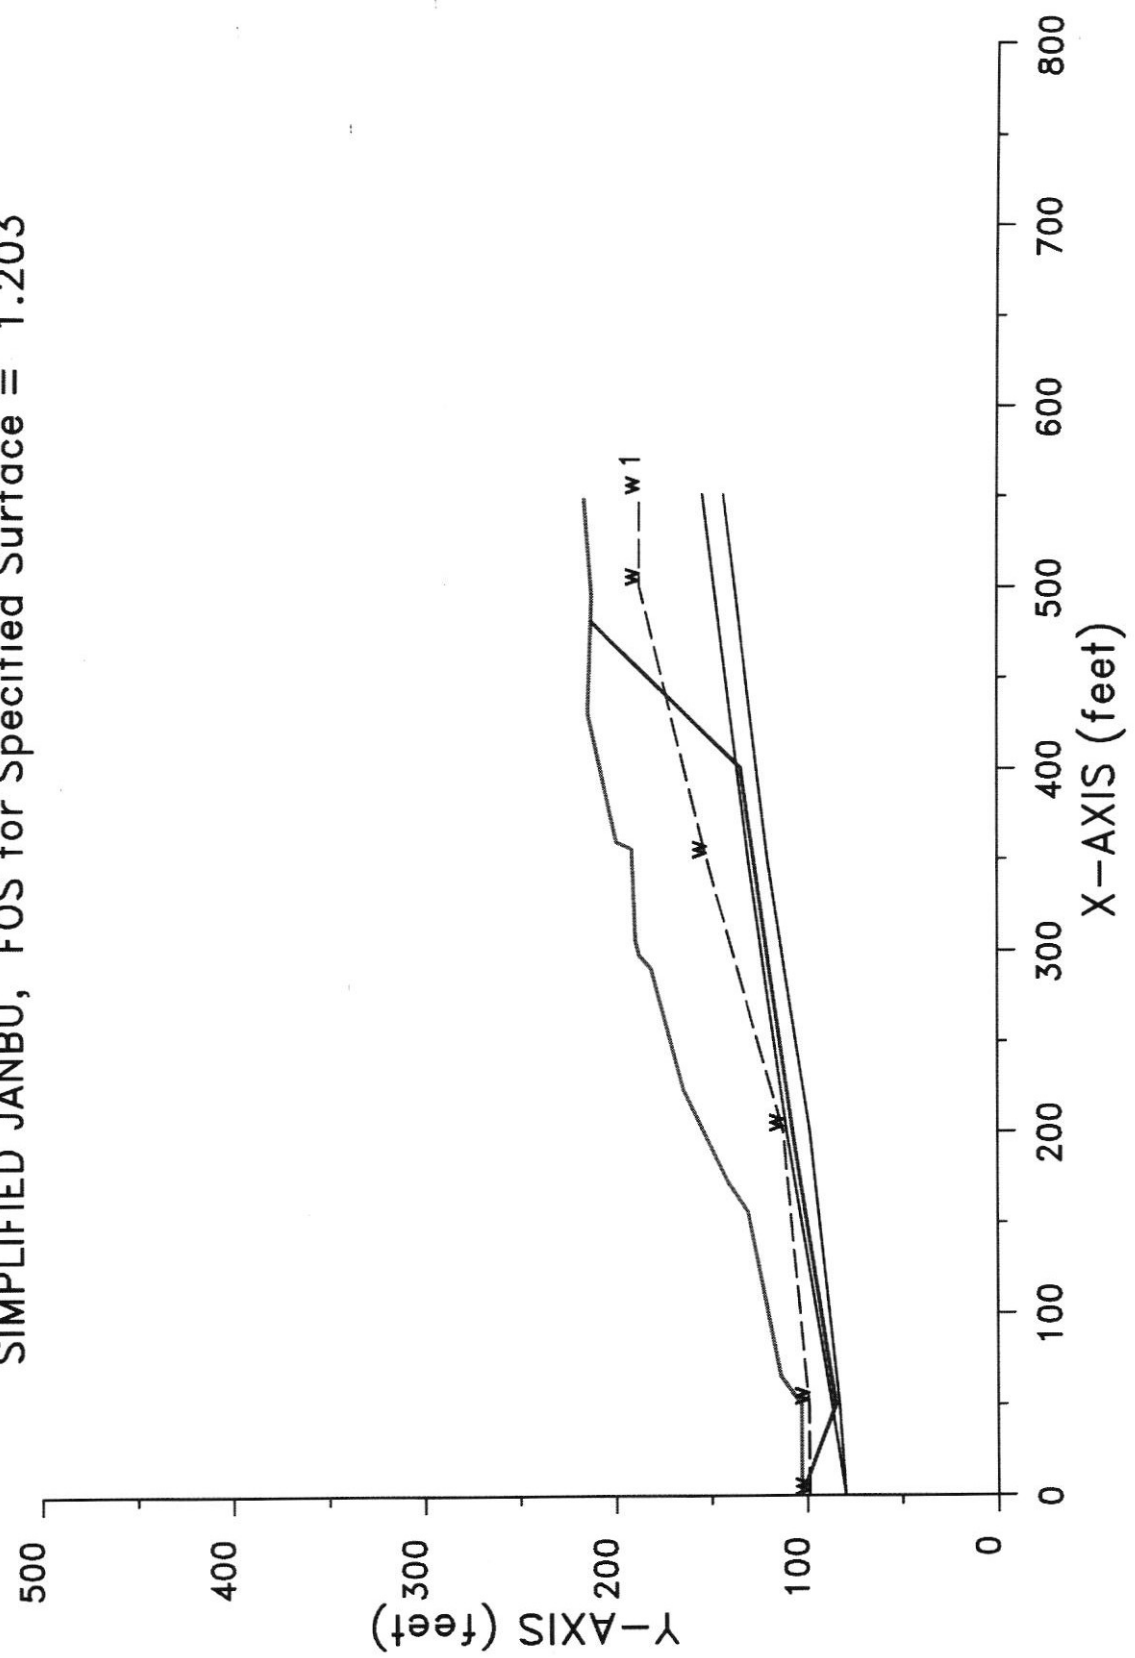
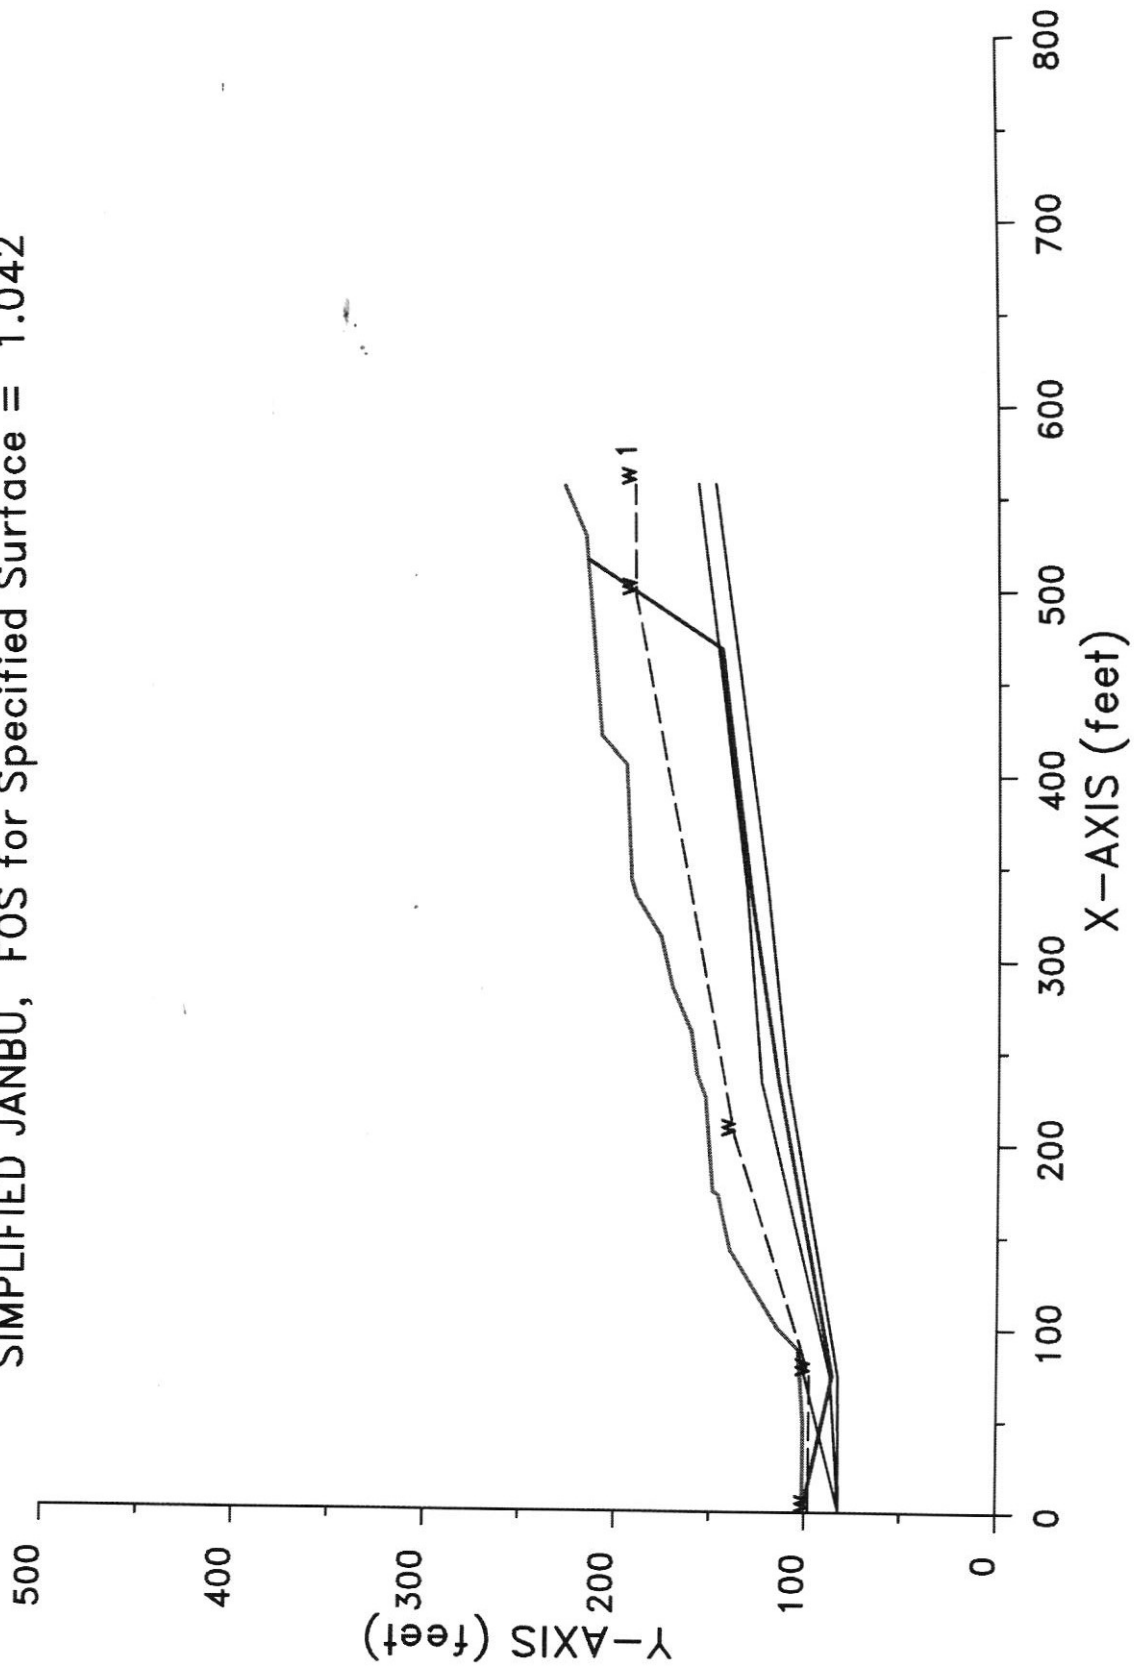
CB2 3-18-03 10:39

S-Curves: Profile 2
SIMPLIFIED JANBU, FOS for Specified Surface = 1.042

S-Curves: Profile 2, low water
SIMPLIFIED JANBU, FOS for Specified Surface = 1.191

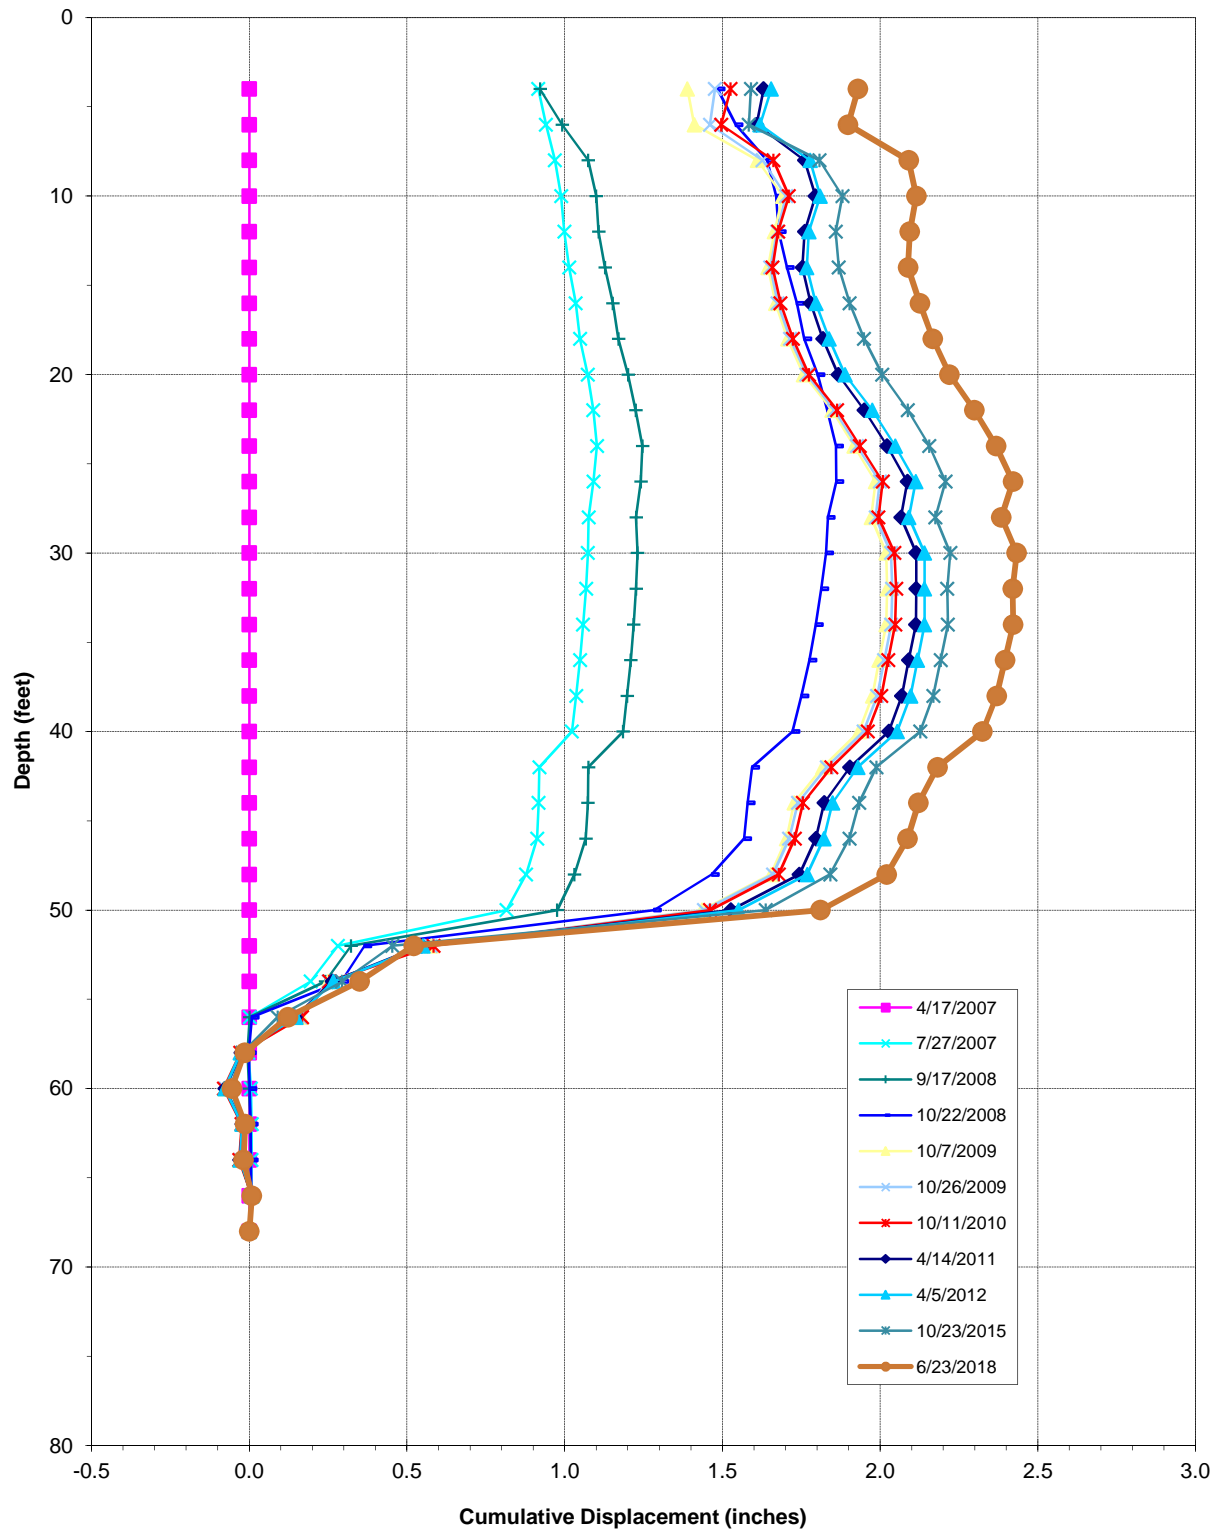
Cannon-02-01-consult2 : B-1r

Roughly 0.2 inches of movement has occurred above/near the primary shear surface since the last reading roughly 3 years ago. The previous 3 years had roughly 0.1 inches of movement. Overall readings show a total of roughly 2.5 inches of movement on this replacement casing. A plot is attached. This movement is not out of recorded context movement rates for the slide.

Although B-Ir is approaching its deflection life, it is still functional and in our opinion does not need replacement at this time. Replacement/redrilling for a new casing (including initial baseline readings) is estimated at roughly \$10,000 as access is difficult. If additional cracking occurs that is more indicative of slide movement, then a new water level logger is recommended for the paired B-I standpipe (P-I).

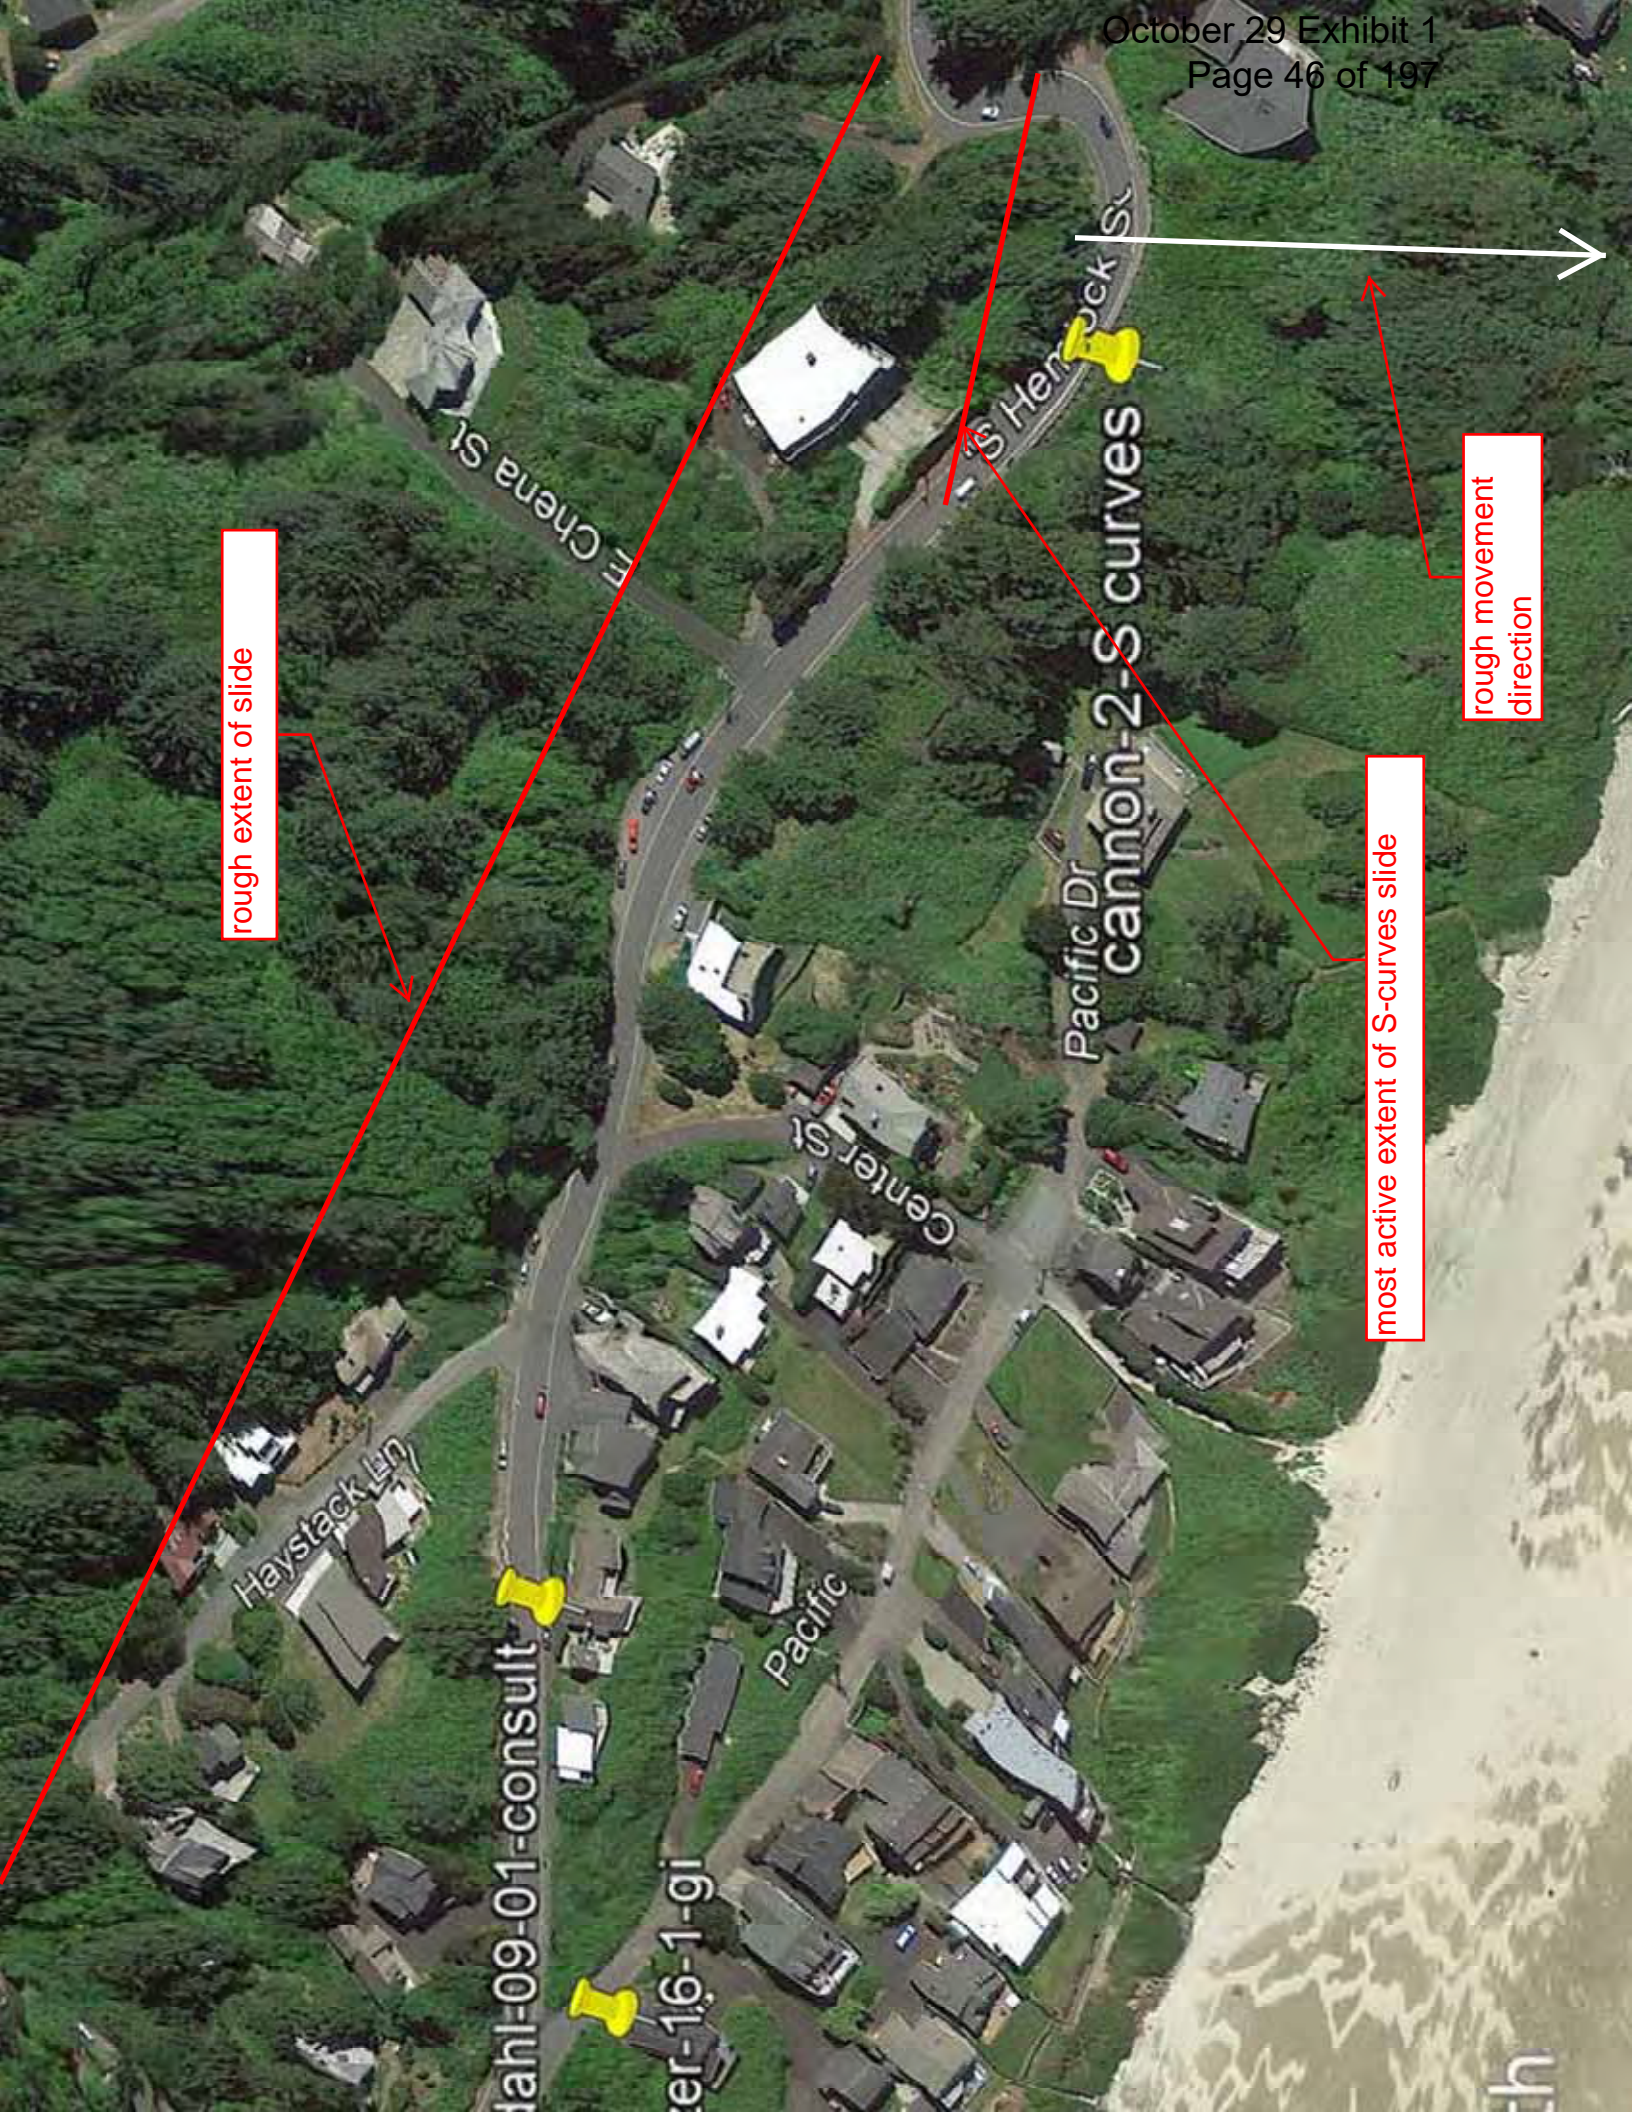
rough extent of slide

most active extent of S-curves slide
