Todd Prager & Associates LLC

MEMORANDUM

DATE: July 21, 2022
TO: Patrick/Dave, LLC
FROM: Todd Prager, RCA #597, ISA Board Certified Master Arborist
RE: Tree Plan for the Forest Lawn Partition

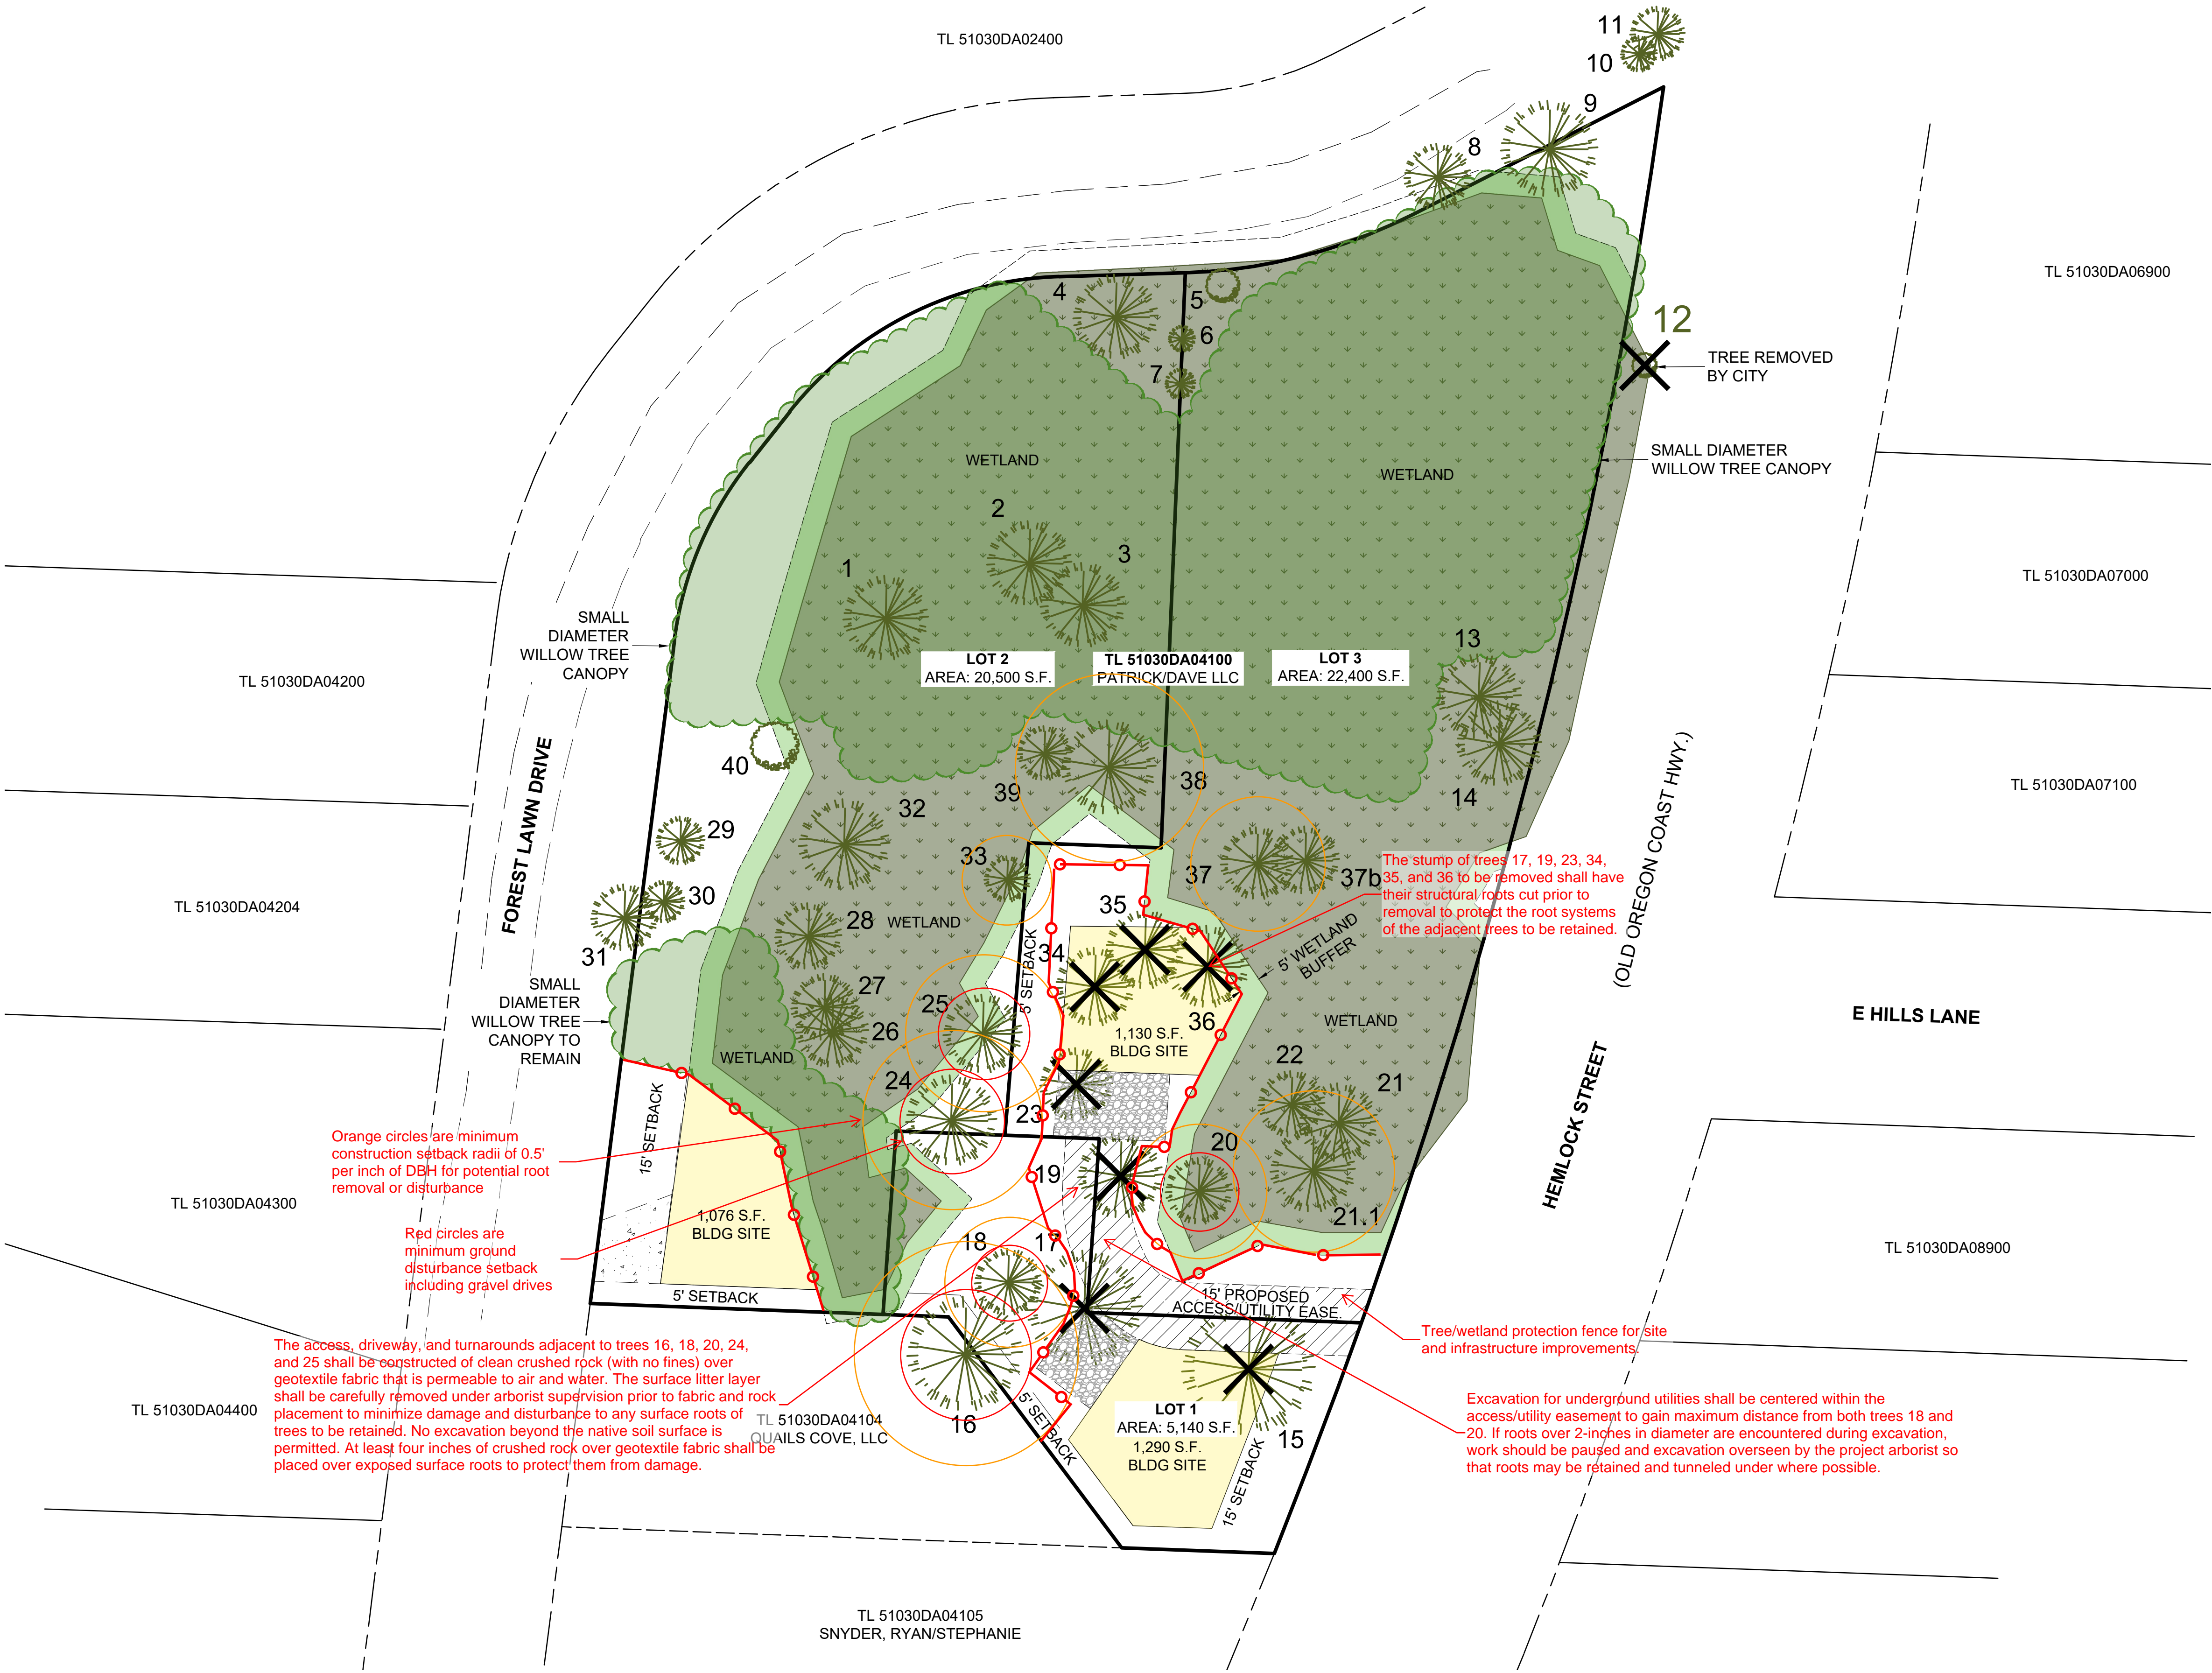
- **Tree 12**, a decayed red alder growing over a culvert, was removed by the City of Cannon Beach based on background I received.
- **Tree 15**, a 60-inch diameter (DBH) Sitka spruce, had a thinning crown compared with other trees at the site.

- **Tree 16**, a 50-inch Sitka spruce on a neighboring property, had a thinning crown compared with other trees at the site and a sweep in its lower trunk towards the northeast.

- **Tree 20**, a 30-inch DBH western hemlock, leaned away from the site and was separated from South Hemlock Street by larger Sitka Spruce that were adjacent to it.

- **Tree 21.1** was added to the site plan in its approximate location by my firm. It was a 36-inch DBH Sitka spruce in good health condition and fair structural condition with codominant stems at approximately 50 feet above ground. Its crown was moderately one sided due to competition with adjacent trees.

- **Tree 34** was a 35-inch DBH Sitka spruce with an approximately 15 percent live crown ratio. Live crown ratio is the ratio of the height of the tree's live foliage to the total height of the tree.

- **Tree 36** was a 36-inch DBH Sitka spruce with a sweep at its lower trunk towards South Hemlock Street.
- **Tree 37b** presently had a relatively low density of *Porodaedalea pini* conks.

- *Tree Protection Fencing:* Tree protection fencing shall be installed in the locations shown in Attachment 1 prior to construction of site and infrastructure improvements. If work is required in the tree protection zones, the project arborist shall be consulted to oversee the work.

- *Access, driveways, and turnaround construction:* The access, driveway, and turnarounds adjacent to trees 16, 18, 20, 24, and 25 shall be constructed of clean crushed rock (with no fines) over geotextile fabric that is permeable to air and water. The surface litter layer shall be carefully removed under arborist supervision prior to fabric and rock placement to minimize damage and disturbance to any surface roots of trees to be retained. No excavation beyond the native soil surface is permitted. At least four inches of crushed rock over geotextile fabric shall be placed over exposed surface roots to protect them from damage.
