Minutes of the CANNON BEACH PLANNING COMMISSION

Thursday, January 26, 2023

Wetland Delineation Tax Lot 4100 Cannon Beach, Oregon

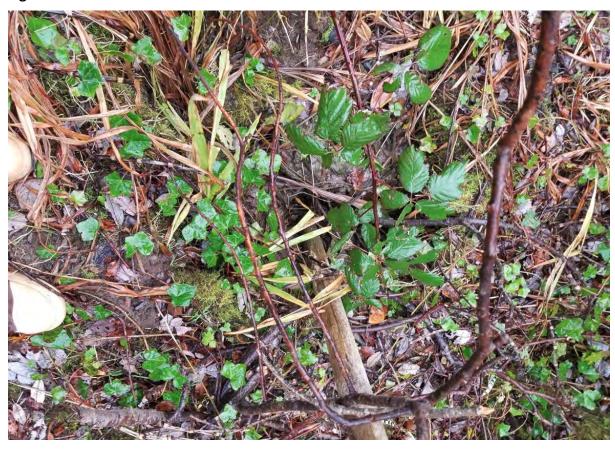
Figure 2: Close-up of Current Outfall

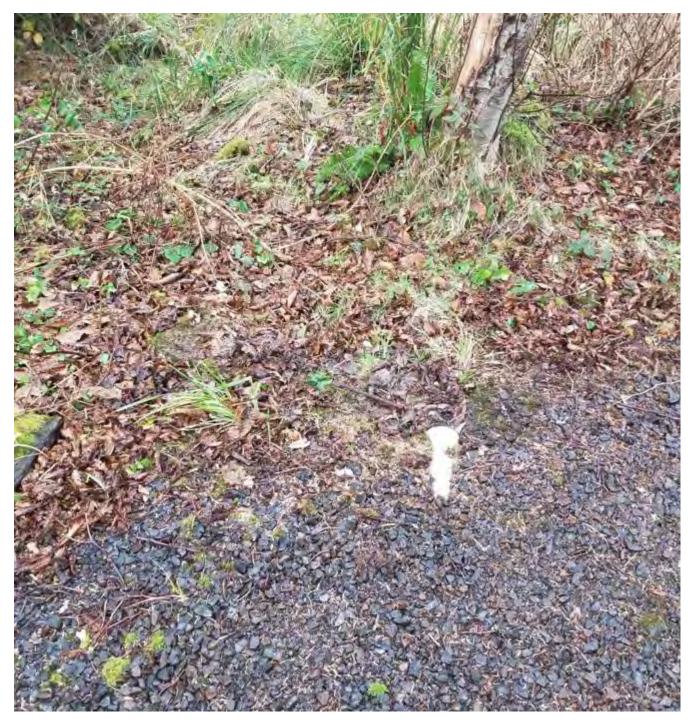
Figure 5: Neighboring property drainage outfall

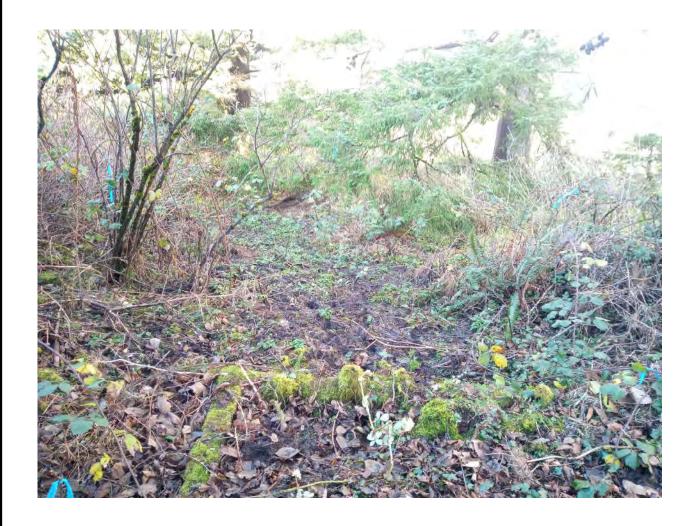
Photo E

Looking north at the southwestern portion of Wetland A, where the house to the south drains stormwater onto the site.

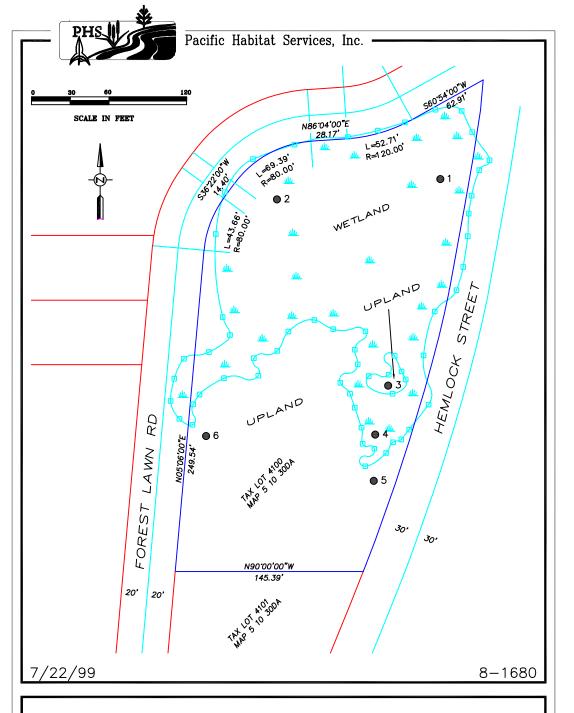
Figure 5: Location of potentially jurisdictional wetlands and sample points for the Forest Lawn Road property in Cannon Beach, Oregon (base map supplied by HLB & Associates).

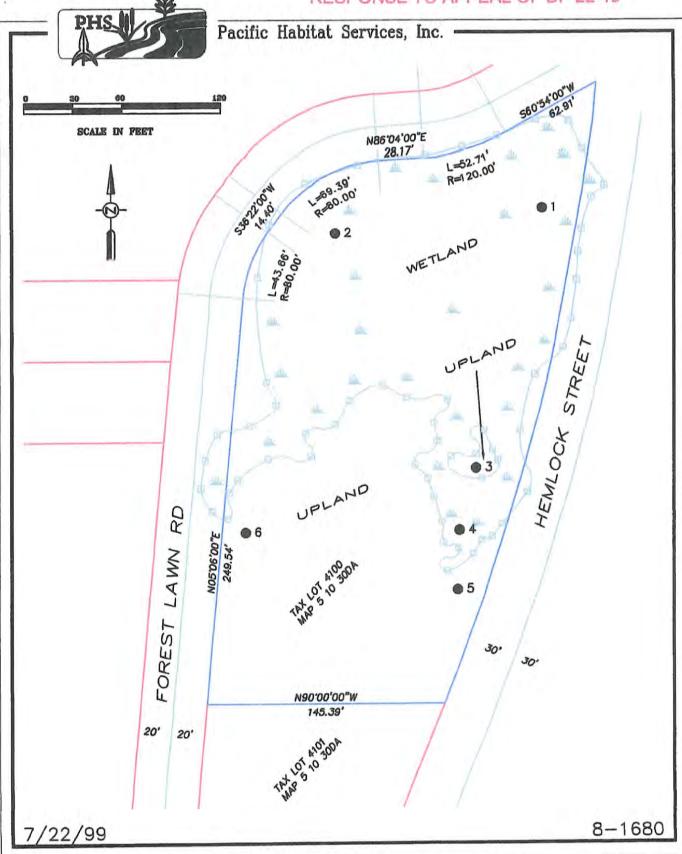
Figure 5: Location of potentially jurisdictional wetlands and sample points for the Forest Lawn Road property in Cannon Beach, Oregon (base map supplied by HLB & Associates).

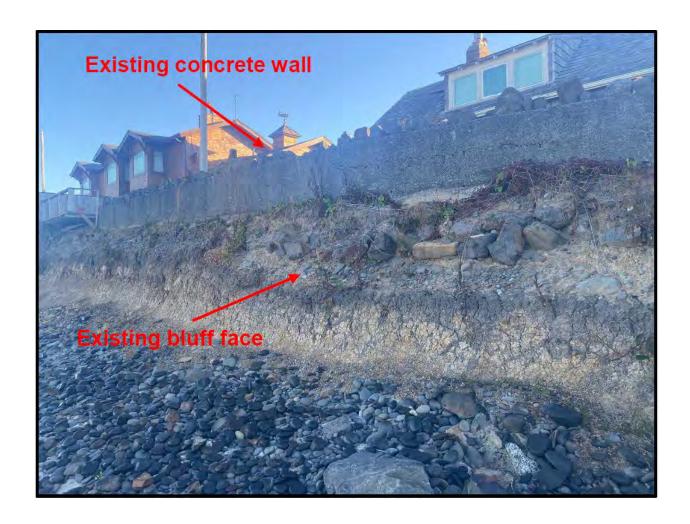
The adjacent beach frontage is approximately 60 feet wide and, as shown in the existing condition photograph below, has no current bluff protection.

The former concrete wall protecting the existing home on the Subject Property was destroyed due to beach erosion sometime in the last decade. As stated in the Geotechnical Investigation and Design Report, prepared by Earth Engineers, Inc., dated November 22, 2022 (the "Engineer's Report) and attached as Exhibit 1, in the absence of permanent shoreline protection, slumping and slope regression will continue resulting in eventual loss of the residence on the Subject Property.

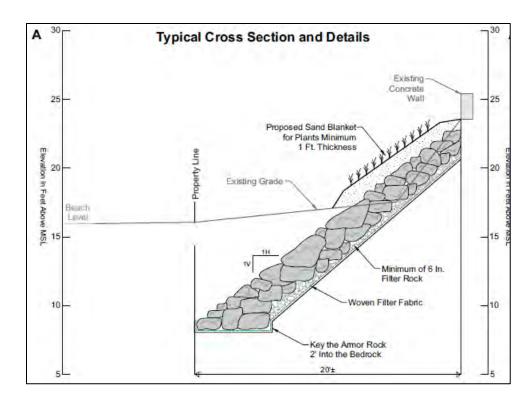
Exhibit 1. The proposed Vegetated Rip-Rap will be "covered with a 1- to 2-foot-thick blanket of sand, then be vegetated with dune grass (or other native plants that are common in Oregon Coast dune environments)." *Id.* Therefore, this criterion is met.

RESPONSE: The proposed Vegetated Rip-Rap is shown in Appendix G to the Engineer's Report, and is designed by a registered engineer (Troy Hull and Yonggui Xie of Earth Engineers Inc.).

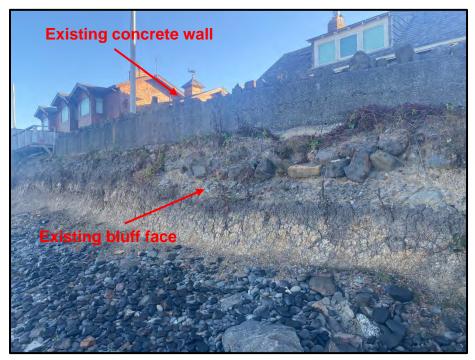
Photo 1: Looking at the current condition of the oceanfront bluff.

The low oceanfront bluff at this location is composed of weakly consolidated marine terrace deposits (see Photo 1). The low beachfront bluff on the west side of the properties in this area to the north of Tolovana Beach State Recreation Area parking lot have historically undergone episodic sloughing and erosion. Over the past few years, the erosion has increased, resulting in undercutting and destruction of a former concrete seawall (Photo 2 and Photo 3). The material at the base of the bluff slope at TL 2100 has been eroded away leaving the bluff in a near-vertical condition. The existing top of the bluff (Photo 1) currently is approximately 16 feet east of the statutory vegetation line (Figure 1, Tax Map) established by the Oregon Beach Bill.

The approximately 8 feet tall bluff face is composed of light brown decomposed sandstone with silt, which has become over steepened and experienced continuous ocean wave erosion. The materials and condition of the bluff at the time of our field investigation is shown on Photo 1.

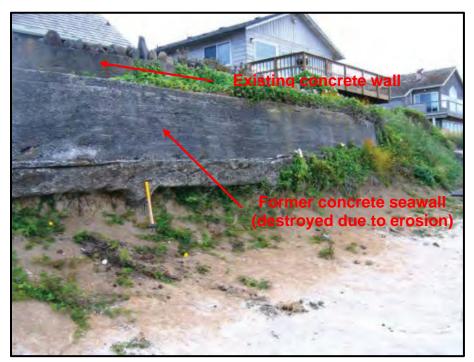
Photo 2: Undated photo of site beachfront and former seawall, presented in Witter et al (2009) as an "example of a seawall in Cannon Beach that has been undermined by wave erosion".

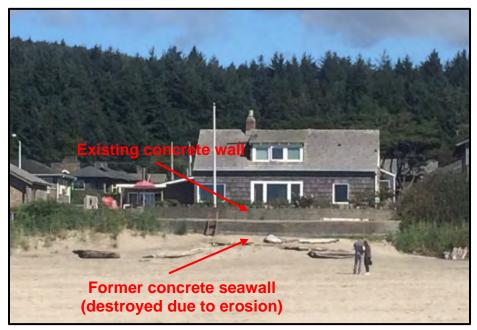
Photo 3: Undated historical photo provided by the property owner, looking east at the subject property and seawall (note that that the beach elevation at the time of the photo is substantially higher than the current beach elevation.)

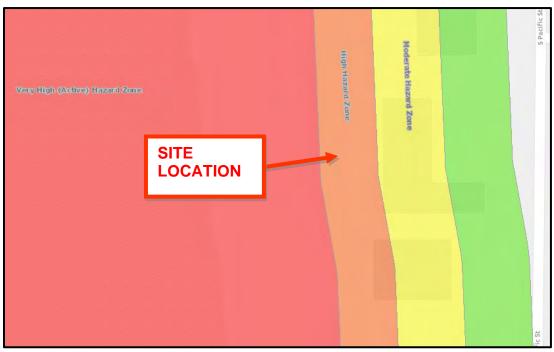
Figure 3: Coastal Erosion Hazard Zone provided by DOGAMI HazVU.

Erosion Cycles and Current Site Condition. During the past quarter century, there has been a general increase in ocean wave erosion observed along much of the Oregon coast. These conditions have been attributed to an increased frequency of relatively severe global climatic episodes, such as El Niño and La Niña periods. The severe storms along the northern Oregon coast during these extremes have resulted increased wave heights and more substantial beachfront erosion than what has been seen in prior recorded history. The severity and frequency of these episodes is expected to increase in the future, and there is near certainty that the rate of sea-level rise will also increase as a result of global warming.

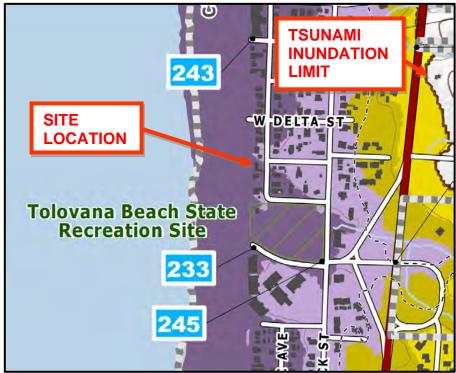
Figure 4: Tsunami hazard map for Cannon Beach provided by DOGAMI. The dark purple shading indicates the area expected to be generated by a "small-sized" Cascadia Subduction Zone Earthquake (earthquake magnitude ~8.7).

Tsunami Hazard. In addition, we reviewed the Tsunami Inundation Map for Cannon Beach, Oregon (reference: https://www.oregongeology.org/pubs/tim/Clat09 CannonBeach Plate1 print.pdf; 2013 Local Source [Cascadia Subduction Zone]). The map shows that this property, along with nearly all of the other beachfront properties in this part of Cannon Beach, is mapped within the tsunami inundation zone (dark purple, light purple, and yellow shaded area in Figure 4 below) and could be impacted by tsunami waves in the event of even a small (magnitude 8.7 or greater) Cascadia Subduction Zone earthquake.

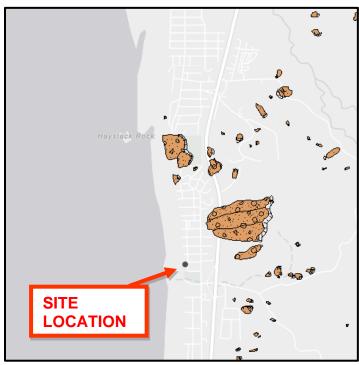
Figure 5: Mapped landslides from DOGAMI's SLIDO (landslides shown as brown notations).

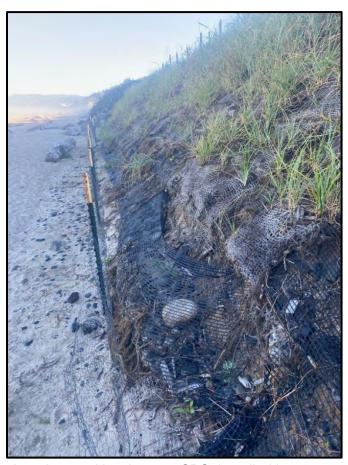
Photo 5. Looking north at the sand burrito-type SPS, installed in 2021 on the western edge of TL 2200. Note the substantial observed vegetation denuding and erosion that has occurred in the course of one winter season.
