**S-Curves Landslide Investigation and Stabilization
Cannon Beach, Oregon**

**Geotech
Solutions Inc.**

GSI Project: Cannon-02-01-gi

GEOTECHNICAL ENGINEERING SERVICES S-Curves Landslide Investigation and Stabilization

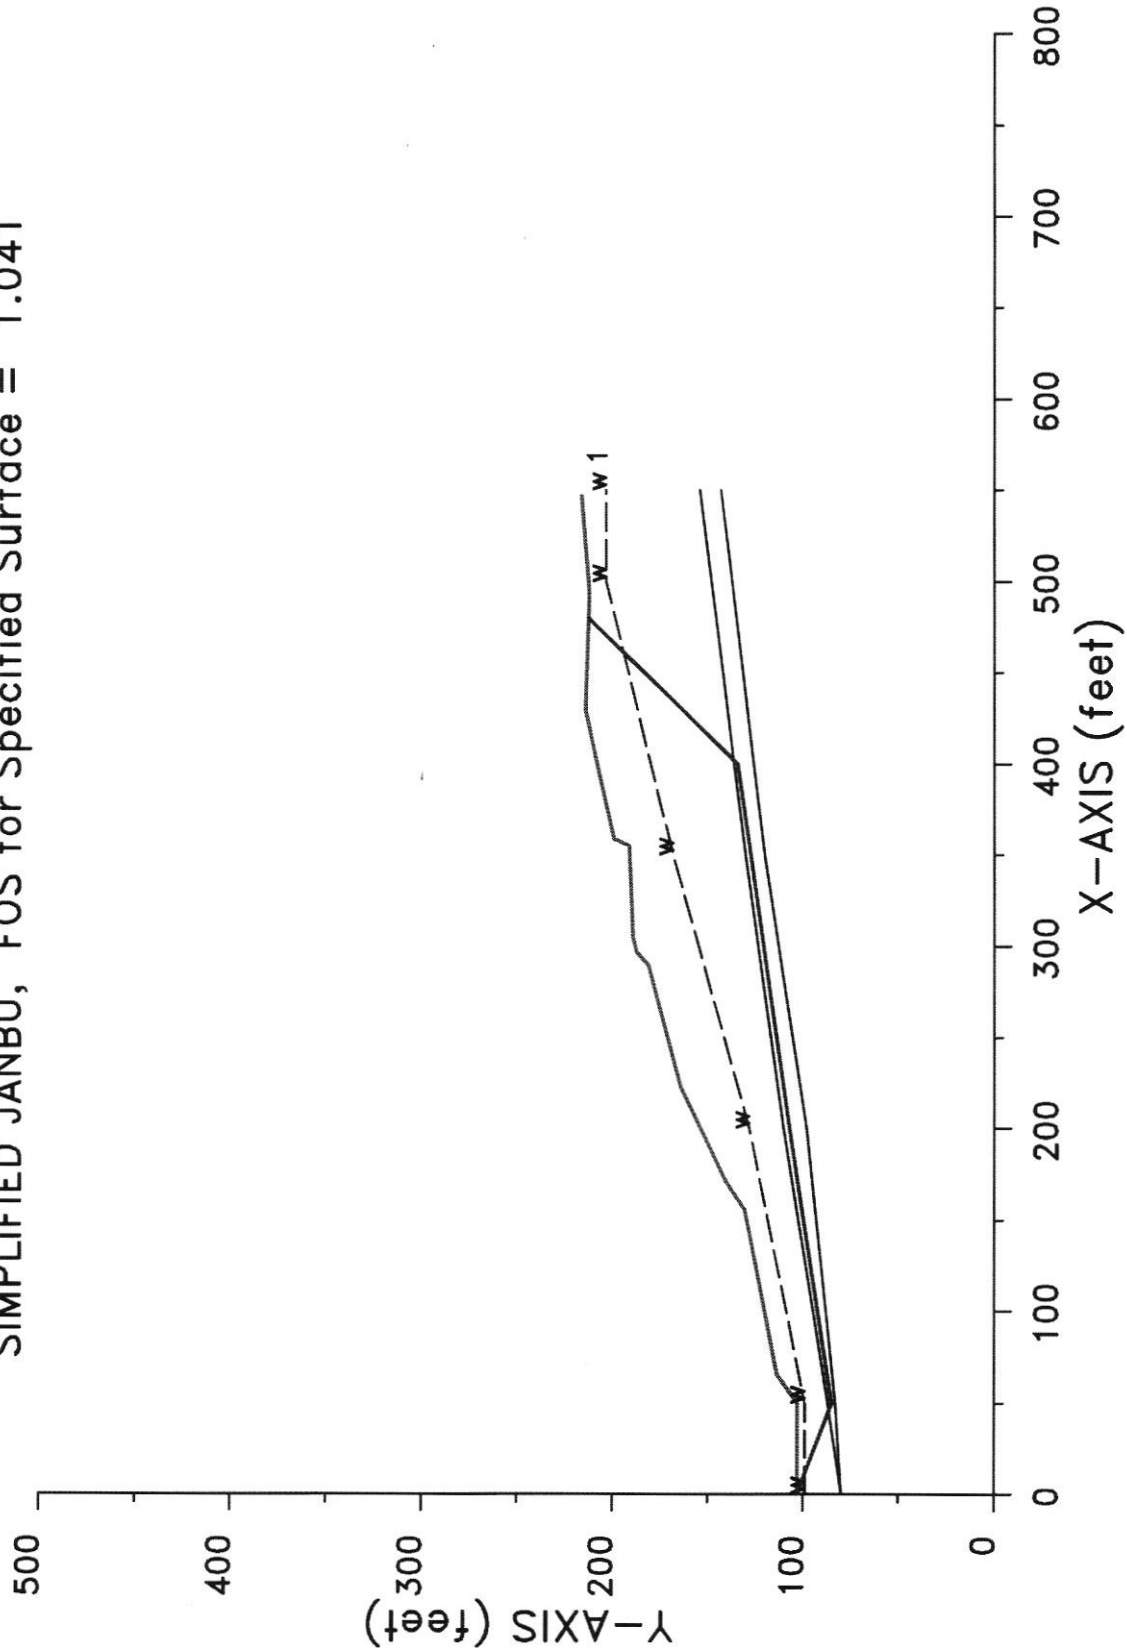
CB1 3-18-03 10:28

S-curves: Profile 1
SIMPLIFIED JANBU, FOS for Specified Surface = 1.041

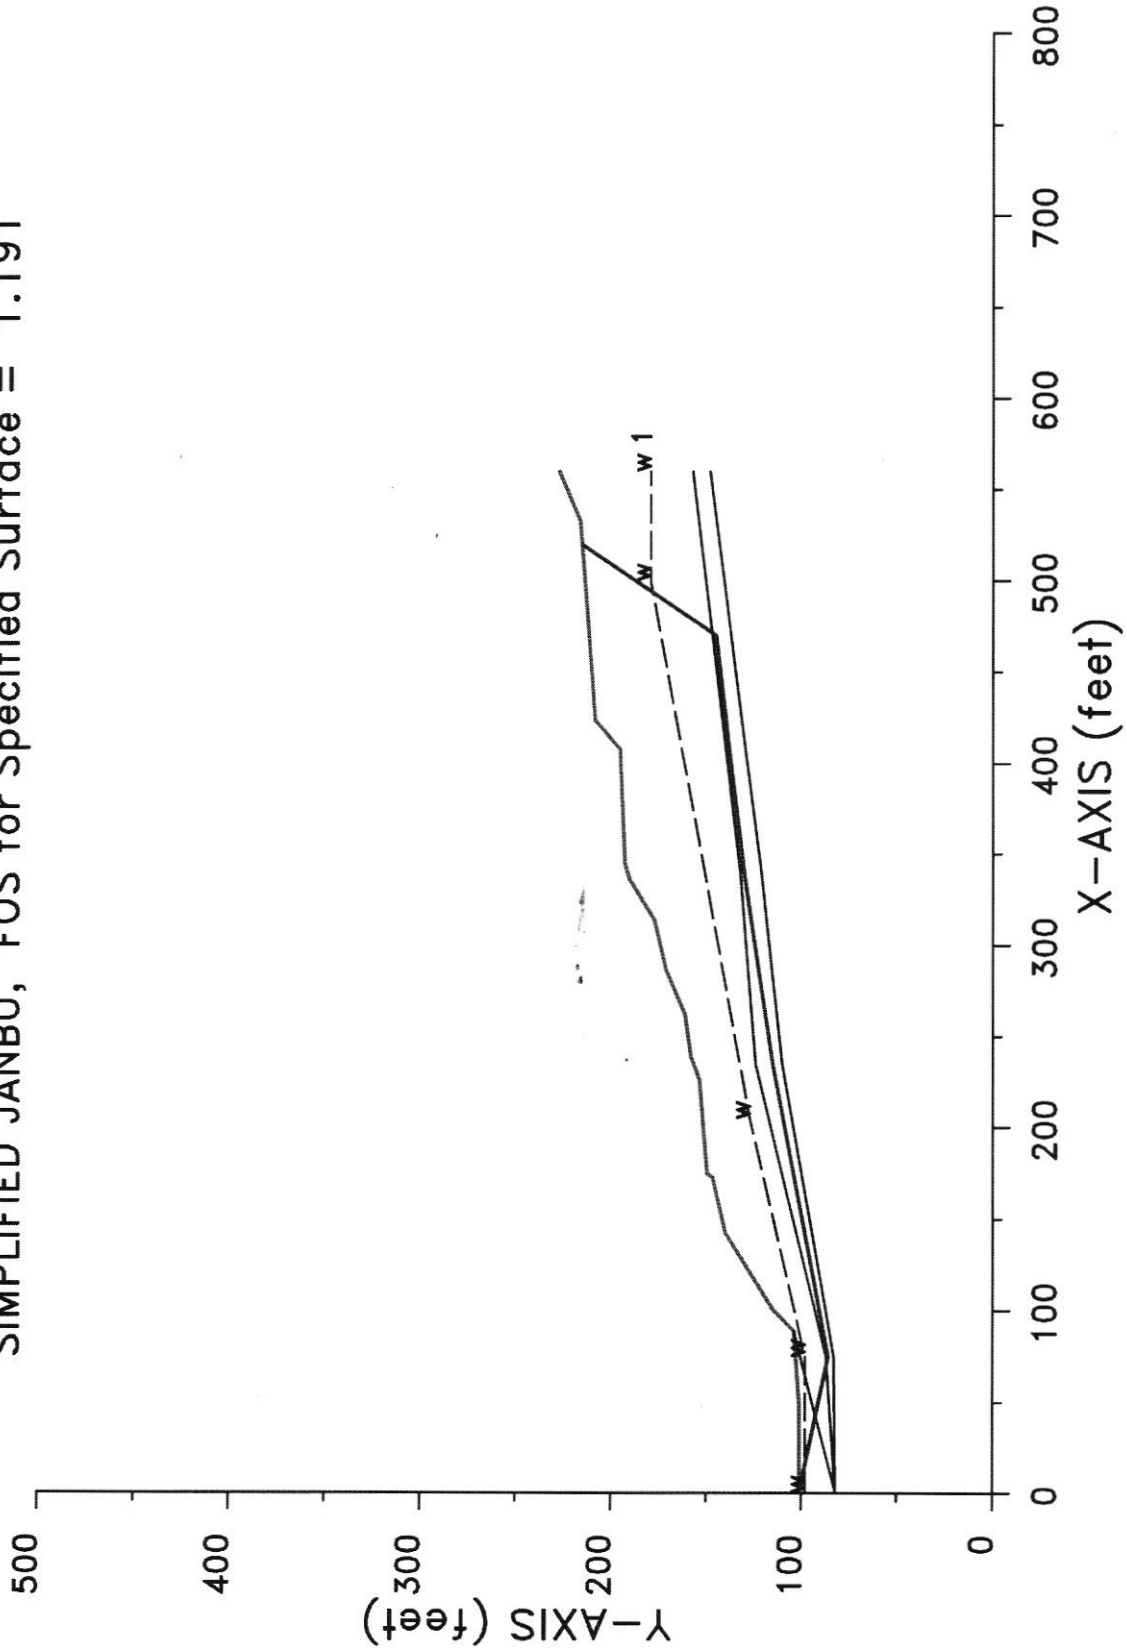
CB2LOW 3-18-03 10:39

S-Curves: Profile 2, low water
SIMPLIFIED JANBU, FOS for Specified Surface = 1.191

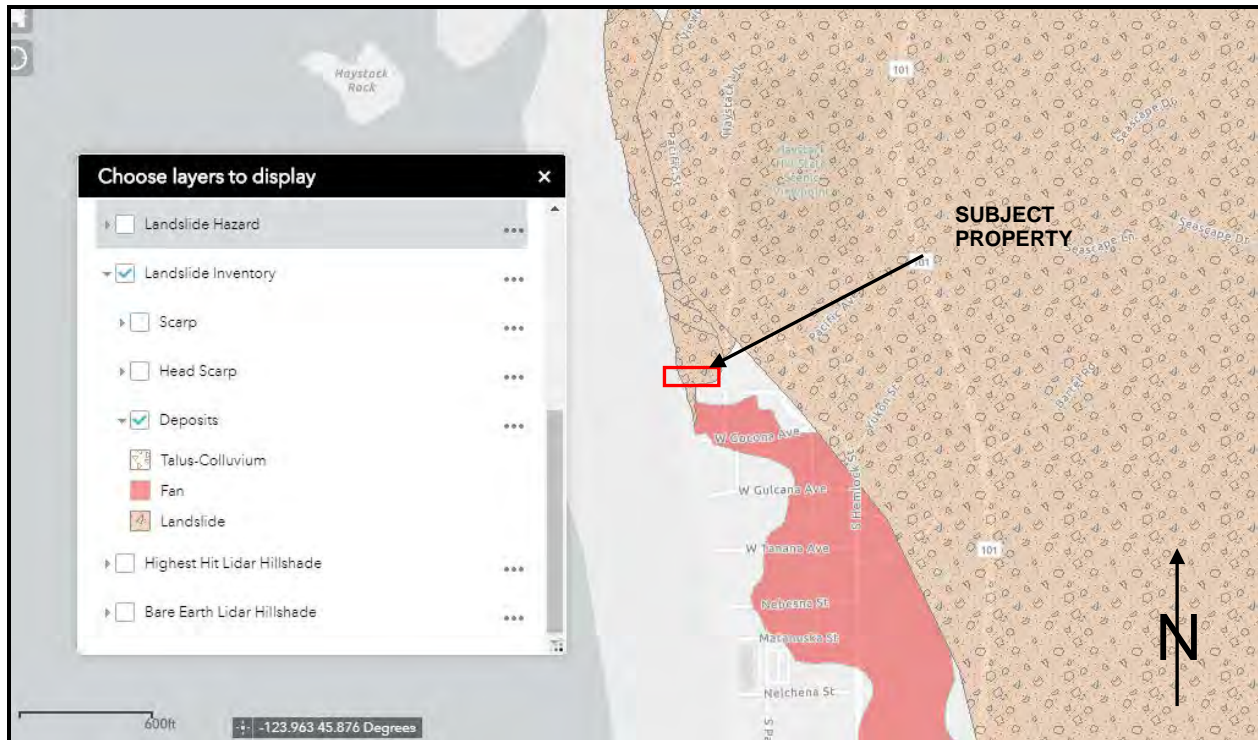
The Nenana Avenue public right-of-way, Tax Lot 600, and adjacent properties are all located within the boundaries of a known active landslide area (S-curves slide) as mapped by the City of Cannon Beach. Principle Geotechnical Engineer Don Rondema with Geotech Solutions Inc. has been involved with and has been working with the City on the S-curves slide since about 1999. According the Geotechnical Engineering Consultation report issued to Stanley Roberts by Geotech Solutions Inc. on July 2, 2019, horizontal drains were installed in 2007 and 2008 and the current slide movement has been reduced to 0.3 inches in the last 6 years. Additionally, the Oregon HazVu: Statewide Geohazards Viewer (<http://www.oregongeology.org/hazvu/>) lists the site as being within a severe to very strong earthquake shaking zone, a very high (active) coastal erosion hazard zone, and a high landslide (landslide likely) hazard area.

Figure 5: Property is located within a large slide mass (base map source: <http://www.oregongeology.org/hazvu/>).

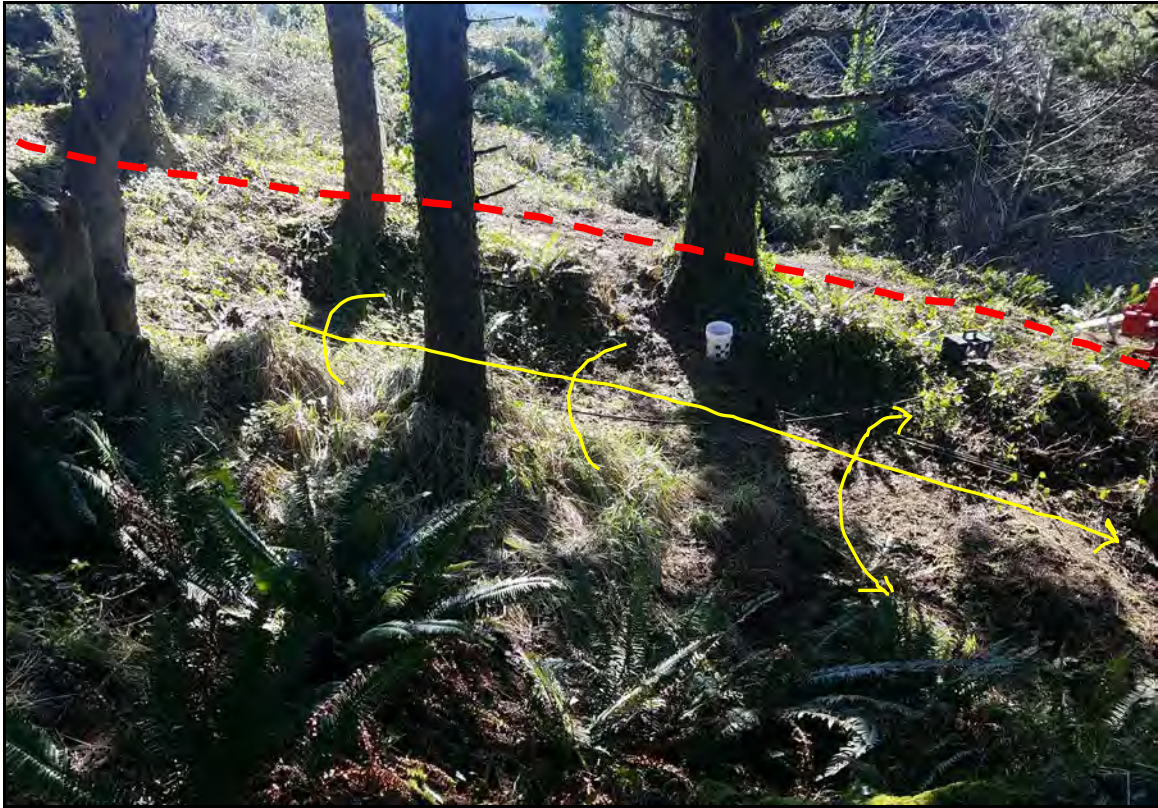
Photo 1: Looking south at the Nenana Avenue right-of-way from north edge of property facing south, showing the existing path (red) and shallow ravine (yellow).

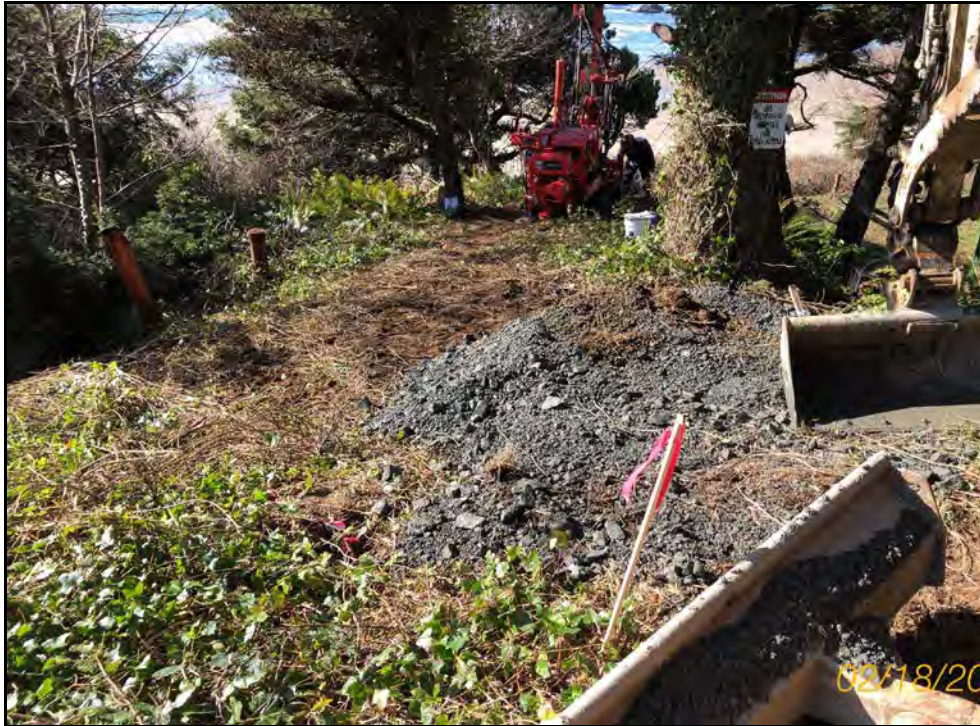
Photo 2: Looking west at the middle portion of the path, sloping down to the west at approximately 15 degrees; drill rig is setup on B-1 in the background.

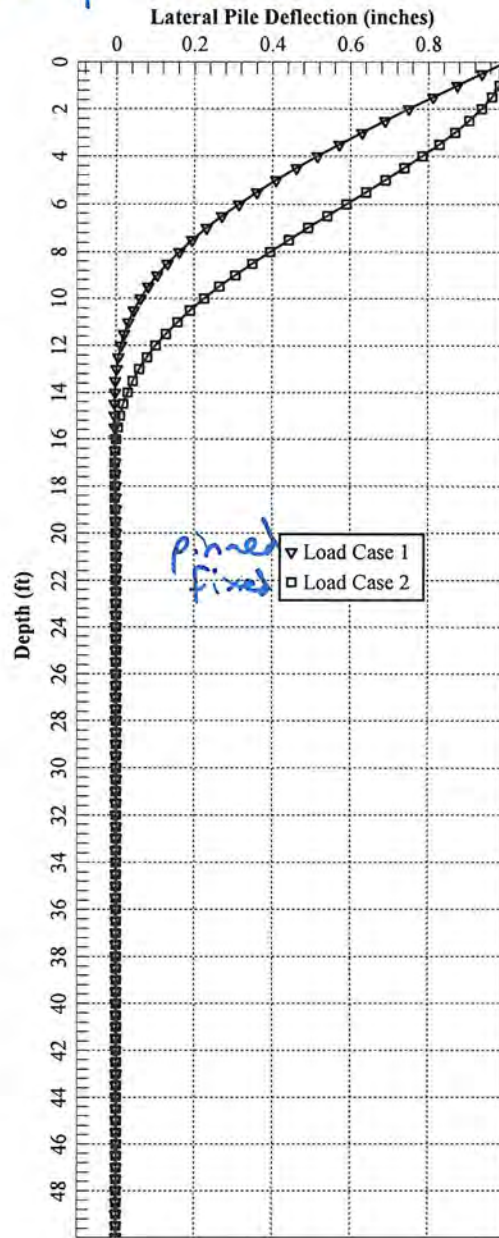
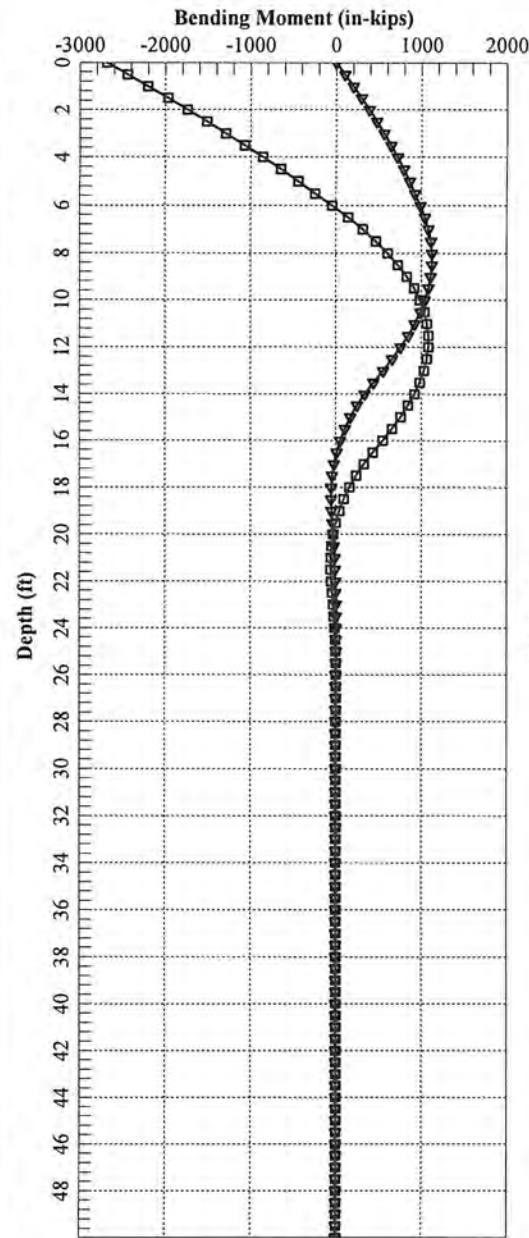
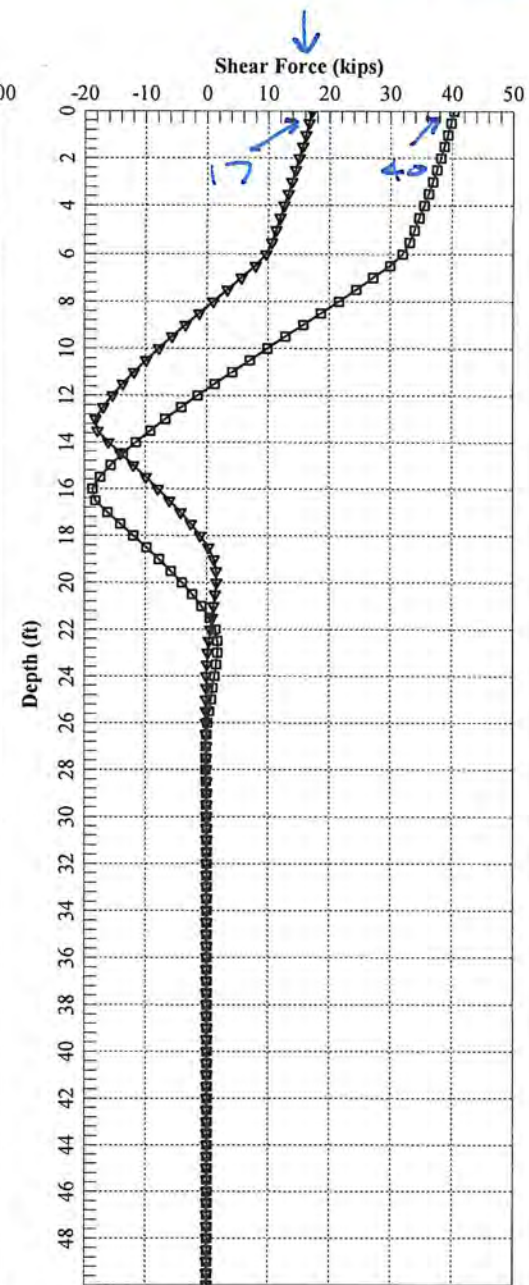
30" pile, strong axis.

Moment = 58.24 K-ft (478,890 in-lb)

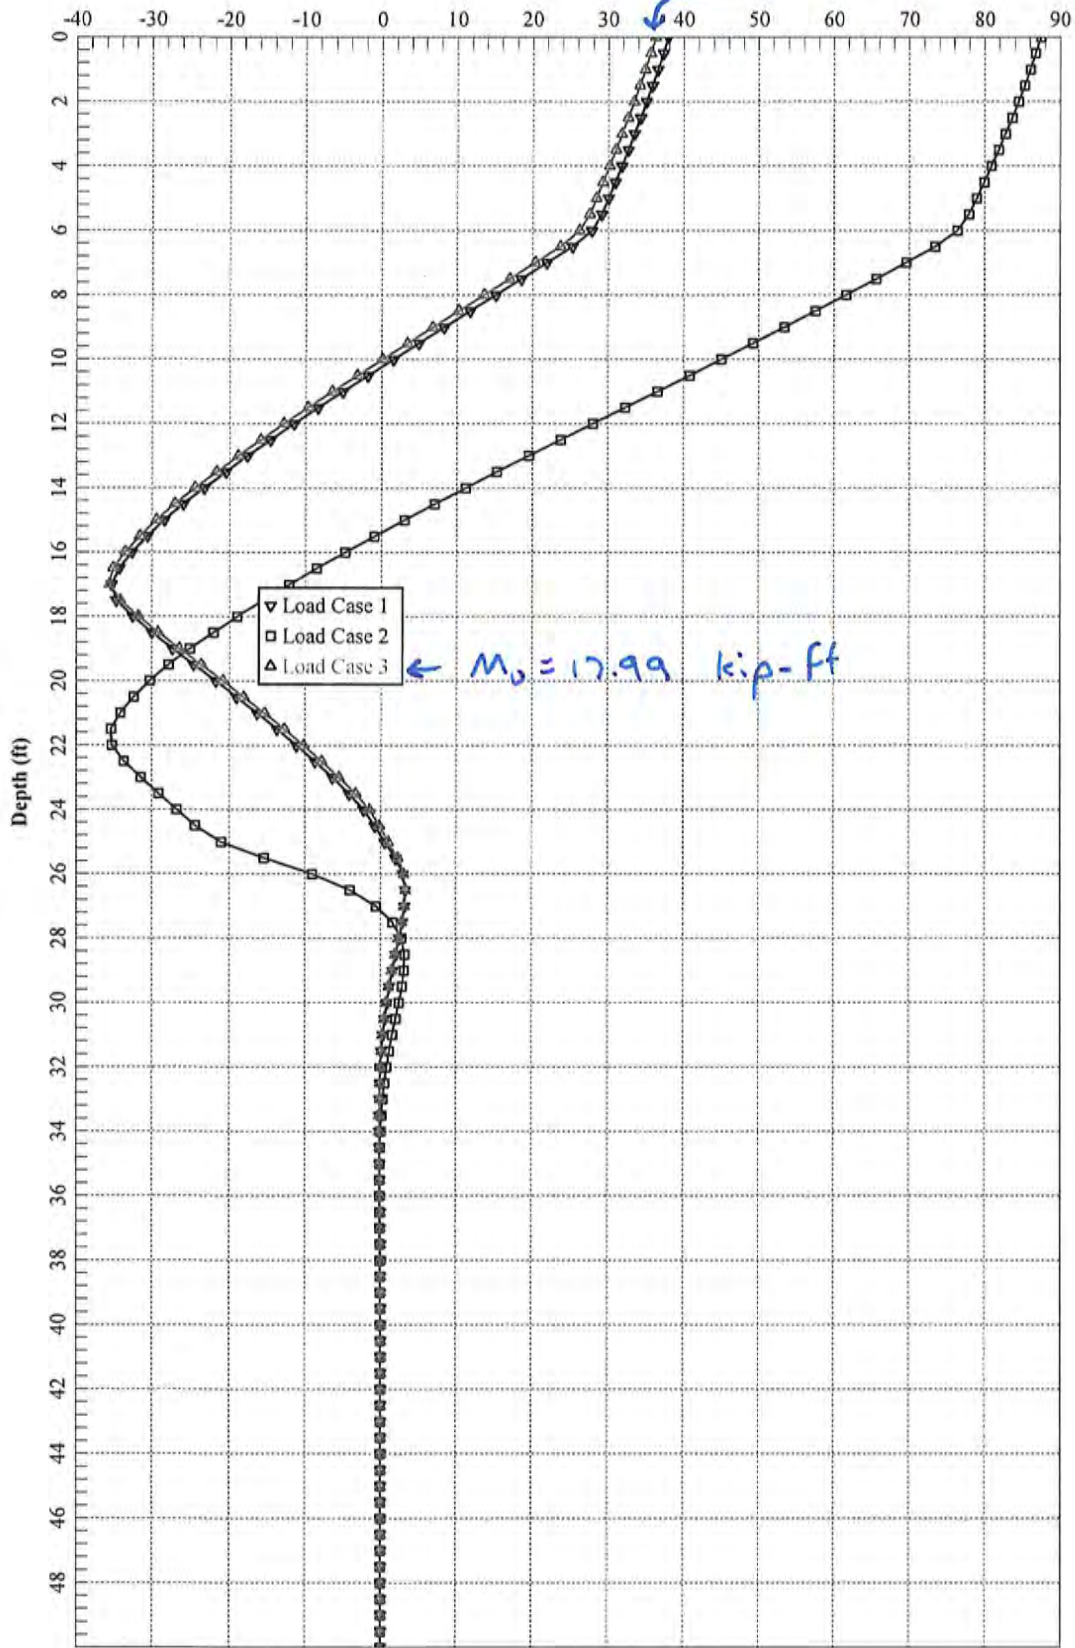
30-INCH DIAMETER DRILLED PIER
Shear Force (kips)

36 kip ultimate

$M_u = 17.99$ kip-ft

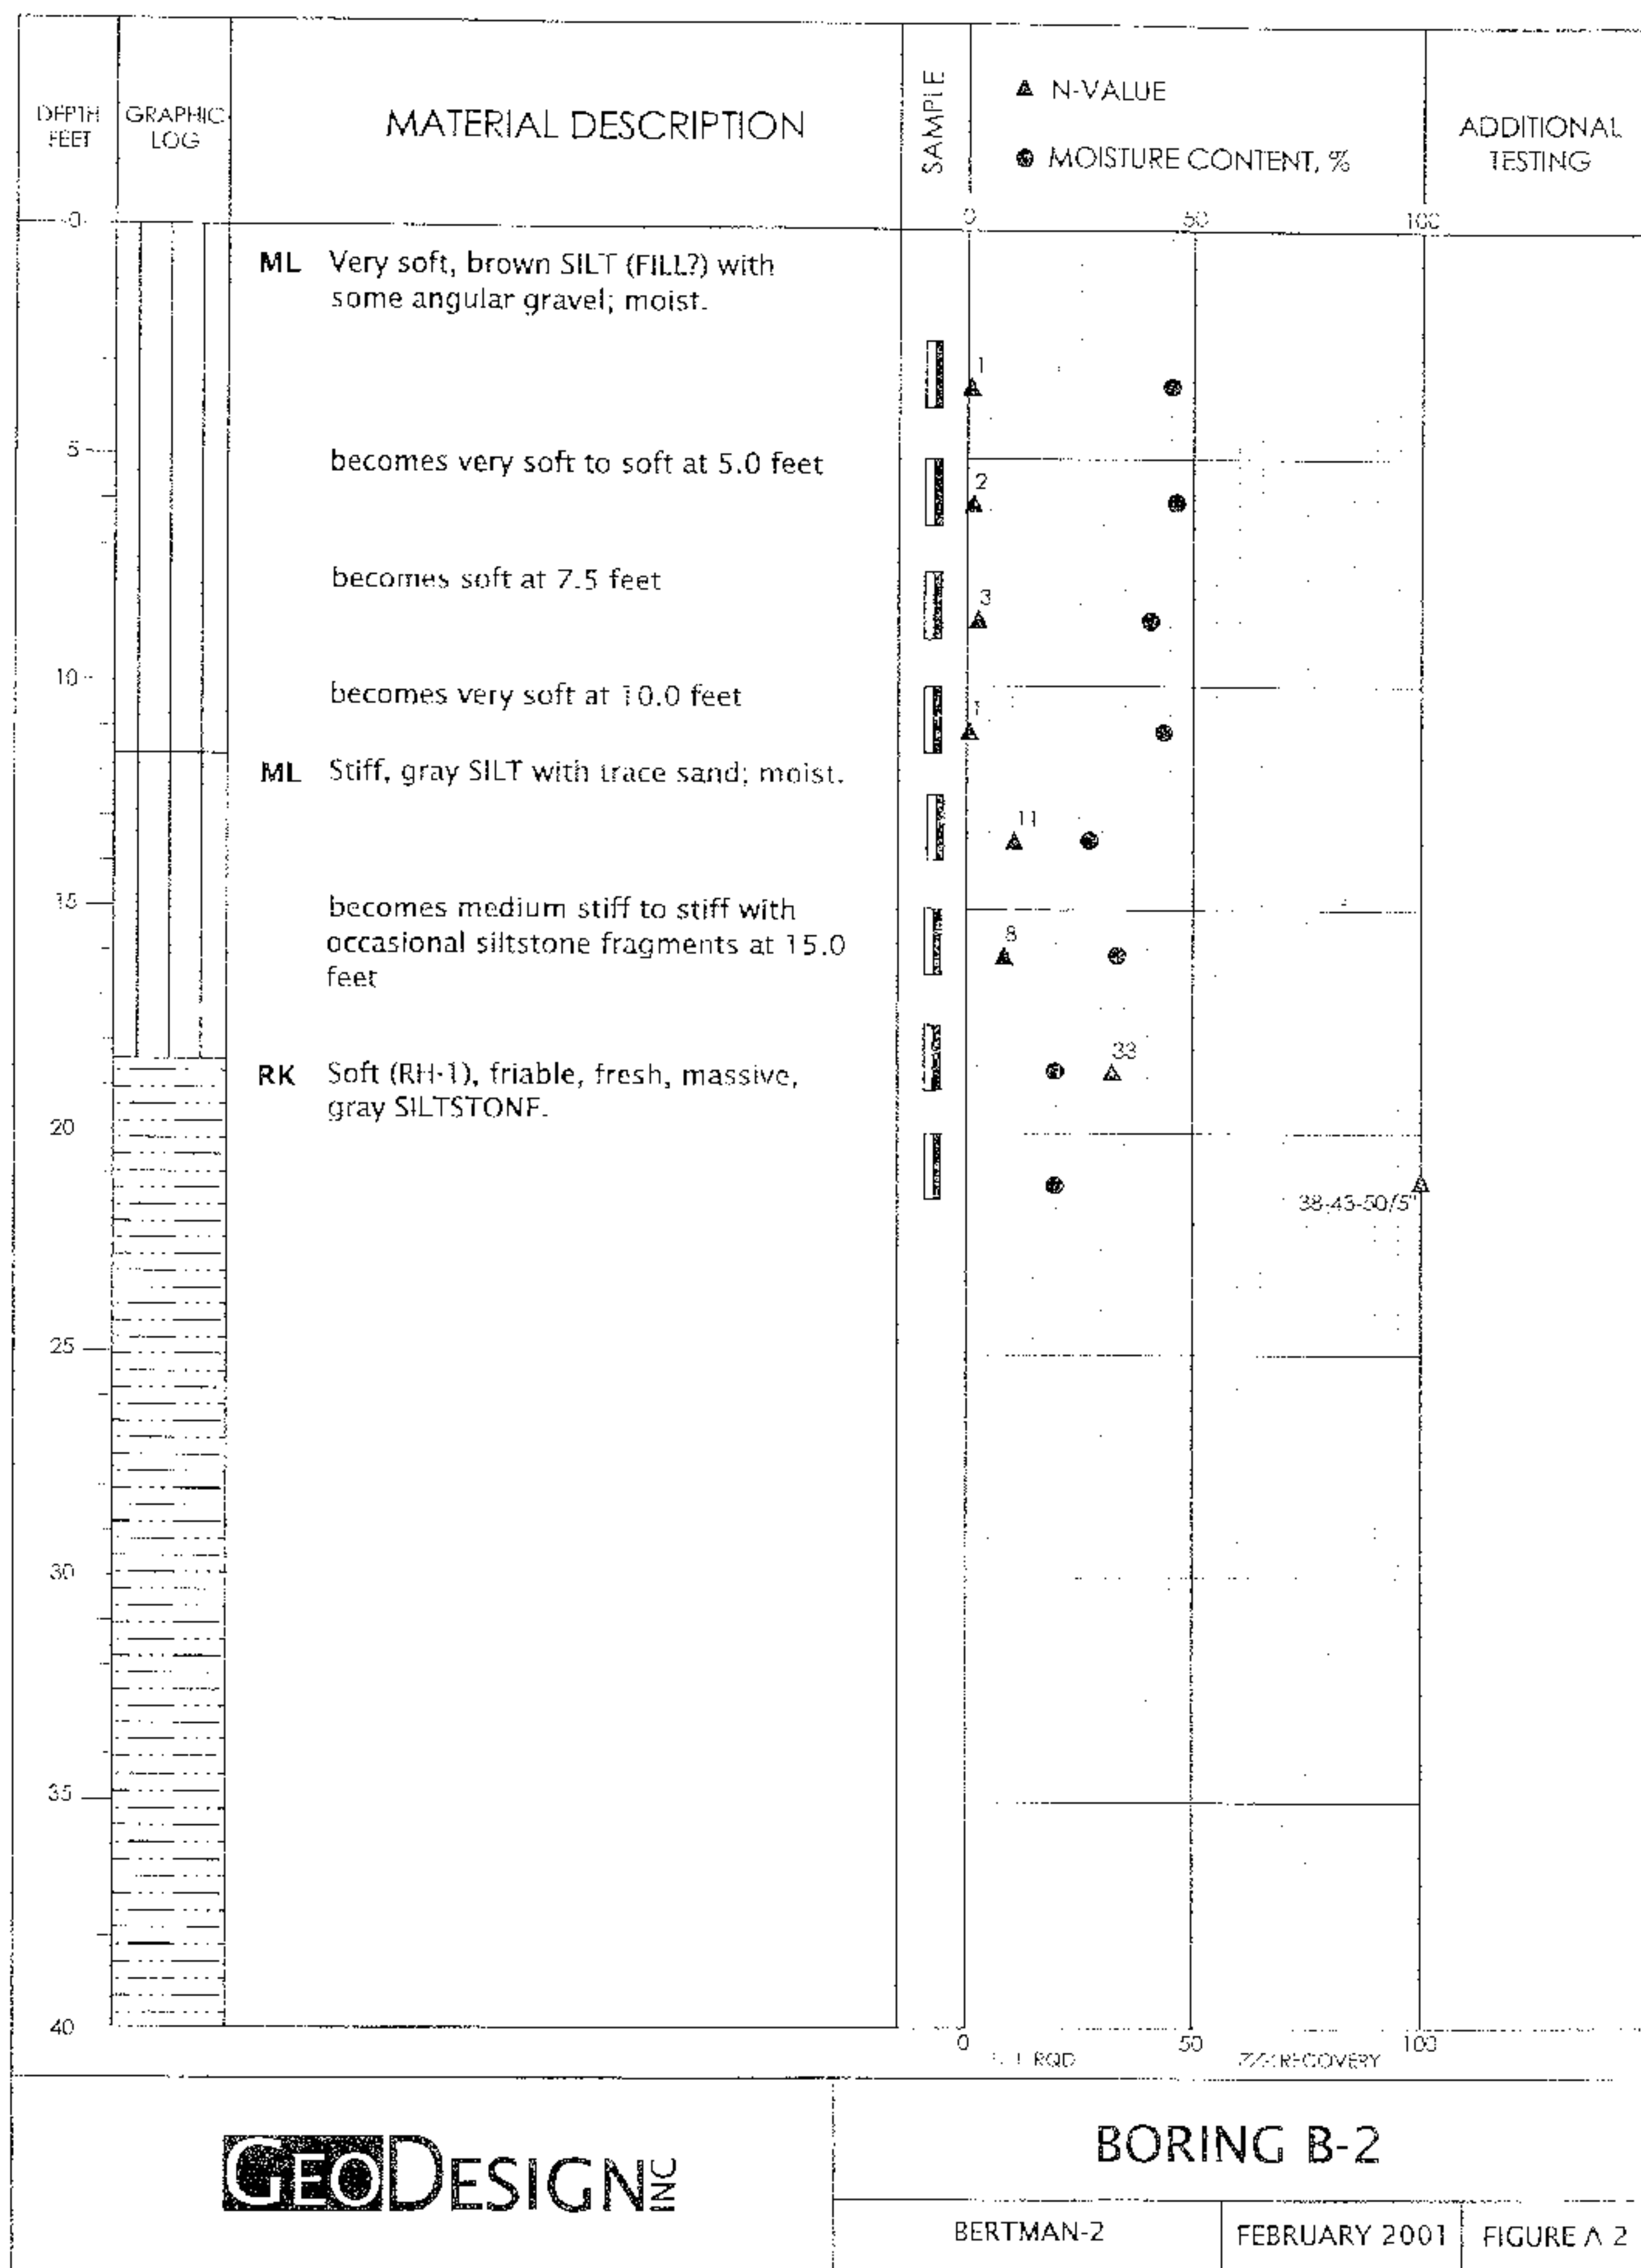
BORING B-2 (CONT.)

DEPTH FEET	GRAPHIC LOG	MATERIAL DESCRIPTION	SAMPLE	▲ N-VALUE ● MOISTURE CONTENT, %	ADDITIONAL TESTING
40			0	50	100
45					
50					
55					
60					
65					
70		Boring completed at 70.0 feet on September 21, 2000. Inclinator casing installed to 45.0 foot depth with above ground monument.			
75					
80					
			0	50	100
				RECOVERY
