CITY OF CANNON BEACH
CITY HALL BUILDING SYSTEMS ANALYSIS

April 3, 2018

PURPOSE STATEMENT

Tolovana Architect, LLC has been retained by the City of Cannon Beach to provide an analysis of the existing City Hall for purposes of determining the feasibility of future improvements.

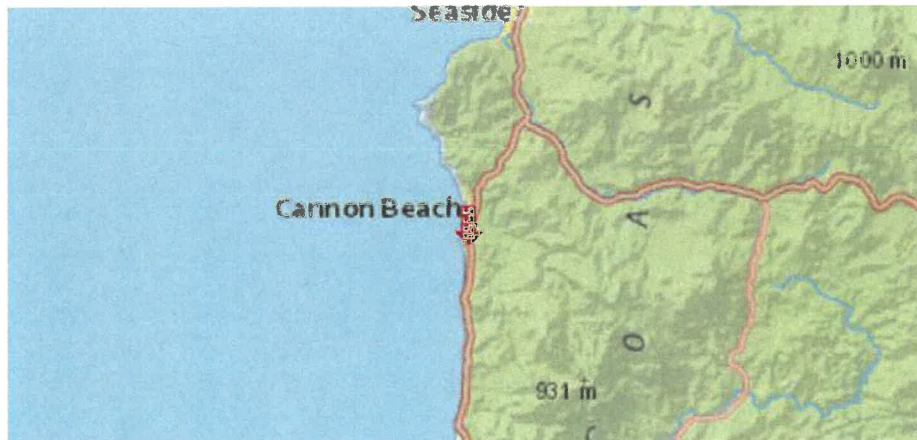
Report Title CB City Hall - Renovation
 Tue November 1, 2016 16:13:27 UTC
Building Code Reference Document 2012/2015 International Building Code
 (which utilizes USGS hazard data available in 2009)
Site Coordinates 45.89°N, 123.96°W
Site Soil Classification Site Class D - "Stiff Soil"
Risk Category I/II/III

USGS-Provided Output

$S_s = 1.340 \text{ g}$ $S_{M5} = 1.340 \text{ g}$ $S_{D5} = 0.894 \text{ g}$
 $S_1 = 0.687 \text{ g}$ $S_{M1} = 1.031 \text{ g}$ $S_{D1} = 0.687 \text{ g}$
