REPORT OF GEOTECHNICAL ENGINEERING SERVICES

**Cannon Beach Cache Site Police Project
Cannon Beach, Oregon**

**Geotech
Solutions Inc.**

REPORT OF GEOTECHNICAL ENGINEERING SERVICES Cache Site Police Station Cannon Beach, Oregon

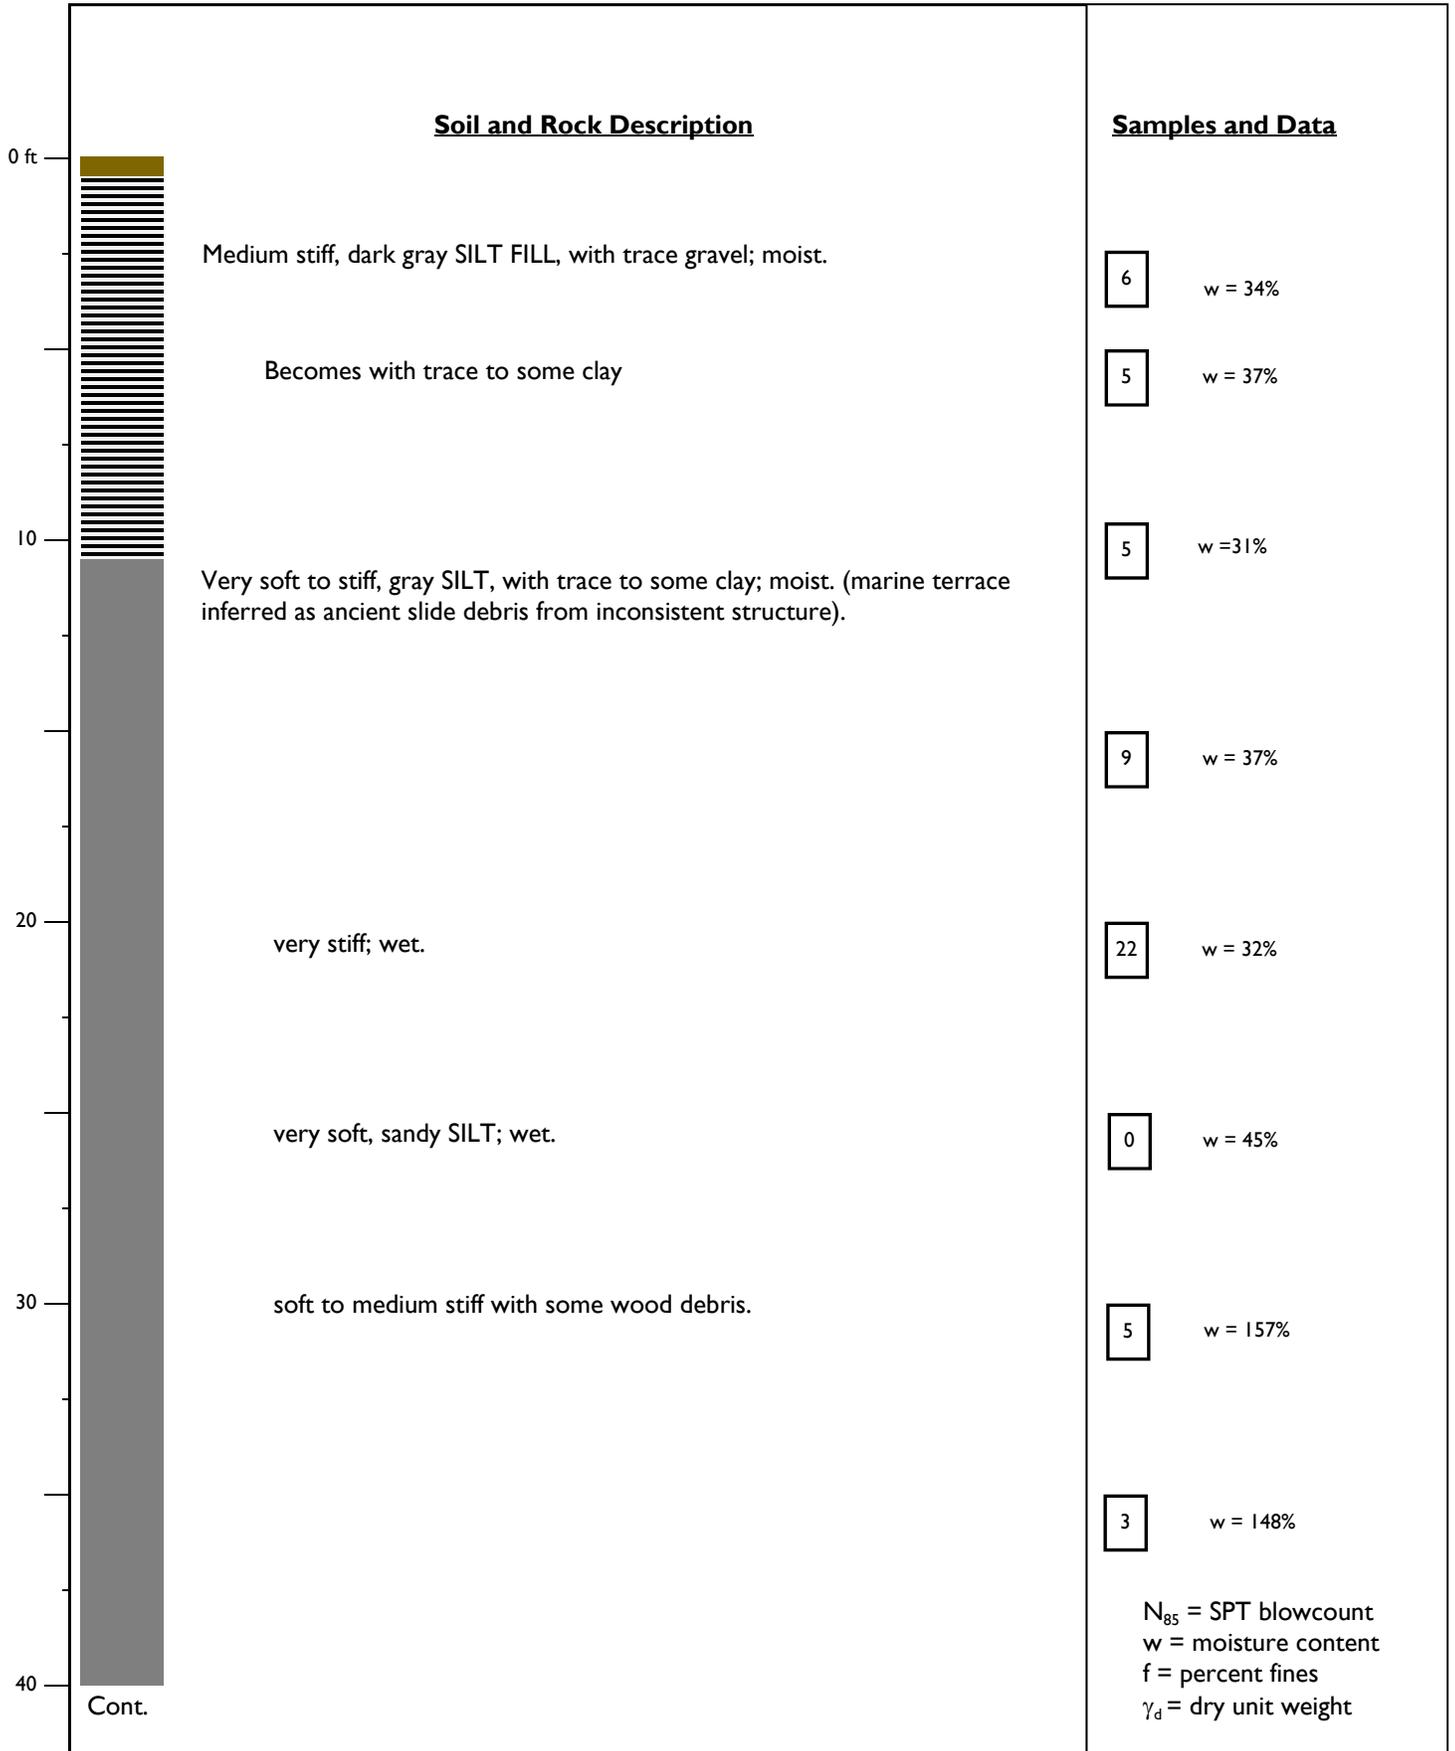
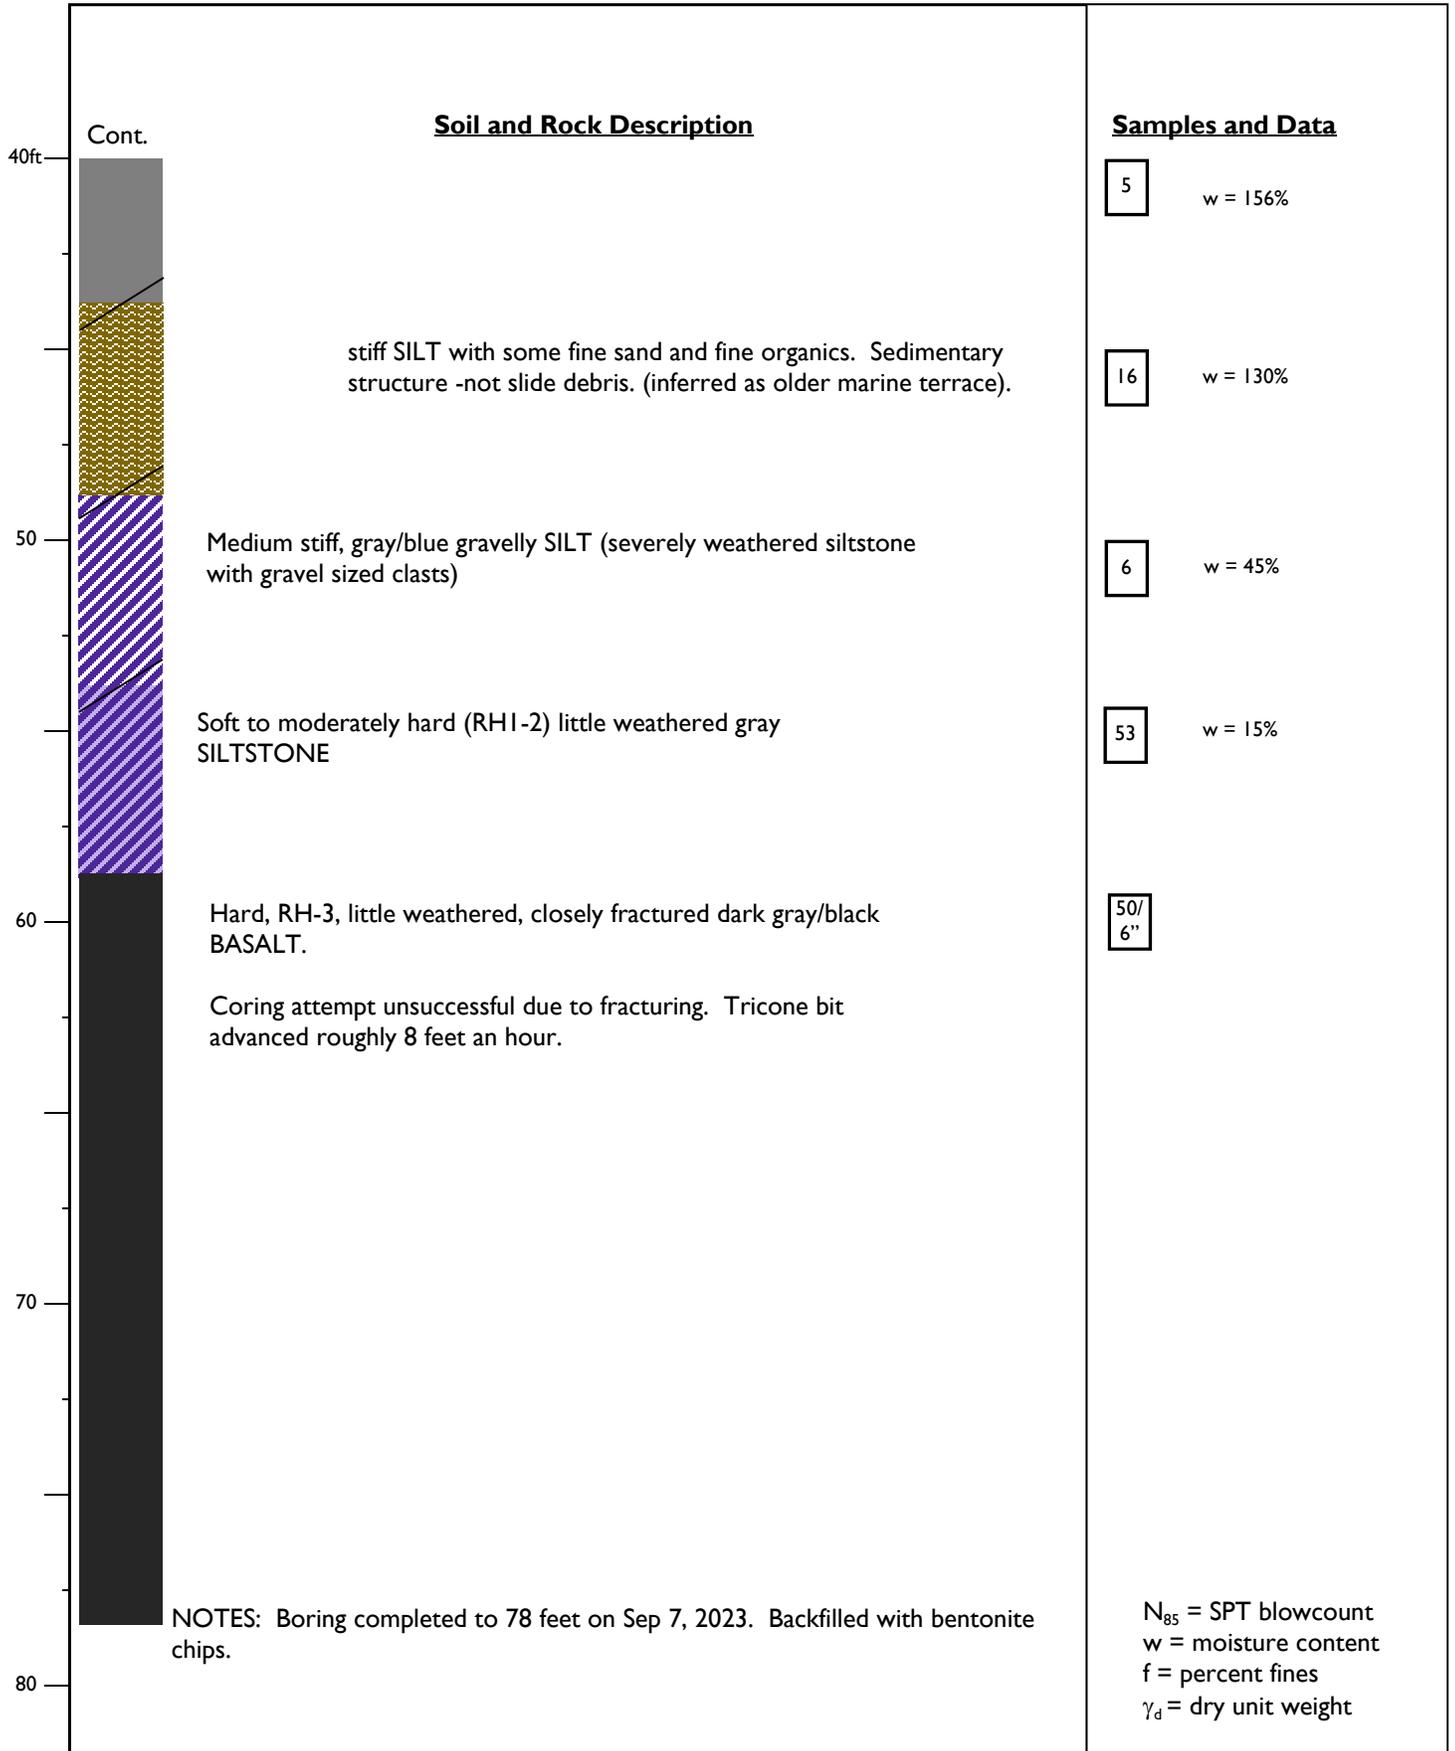
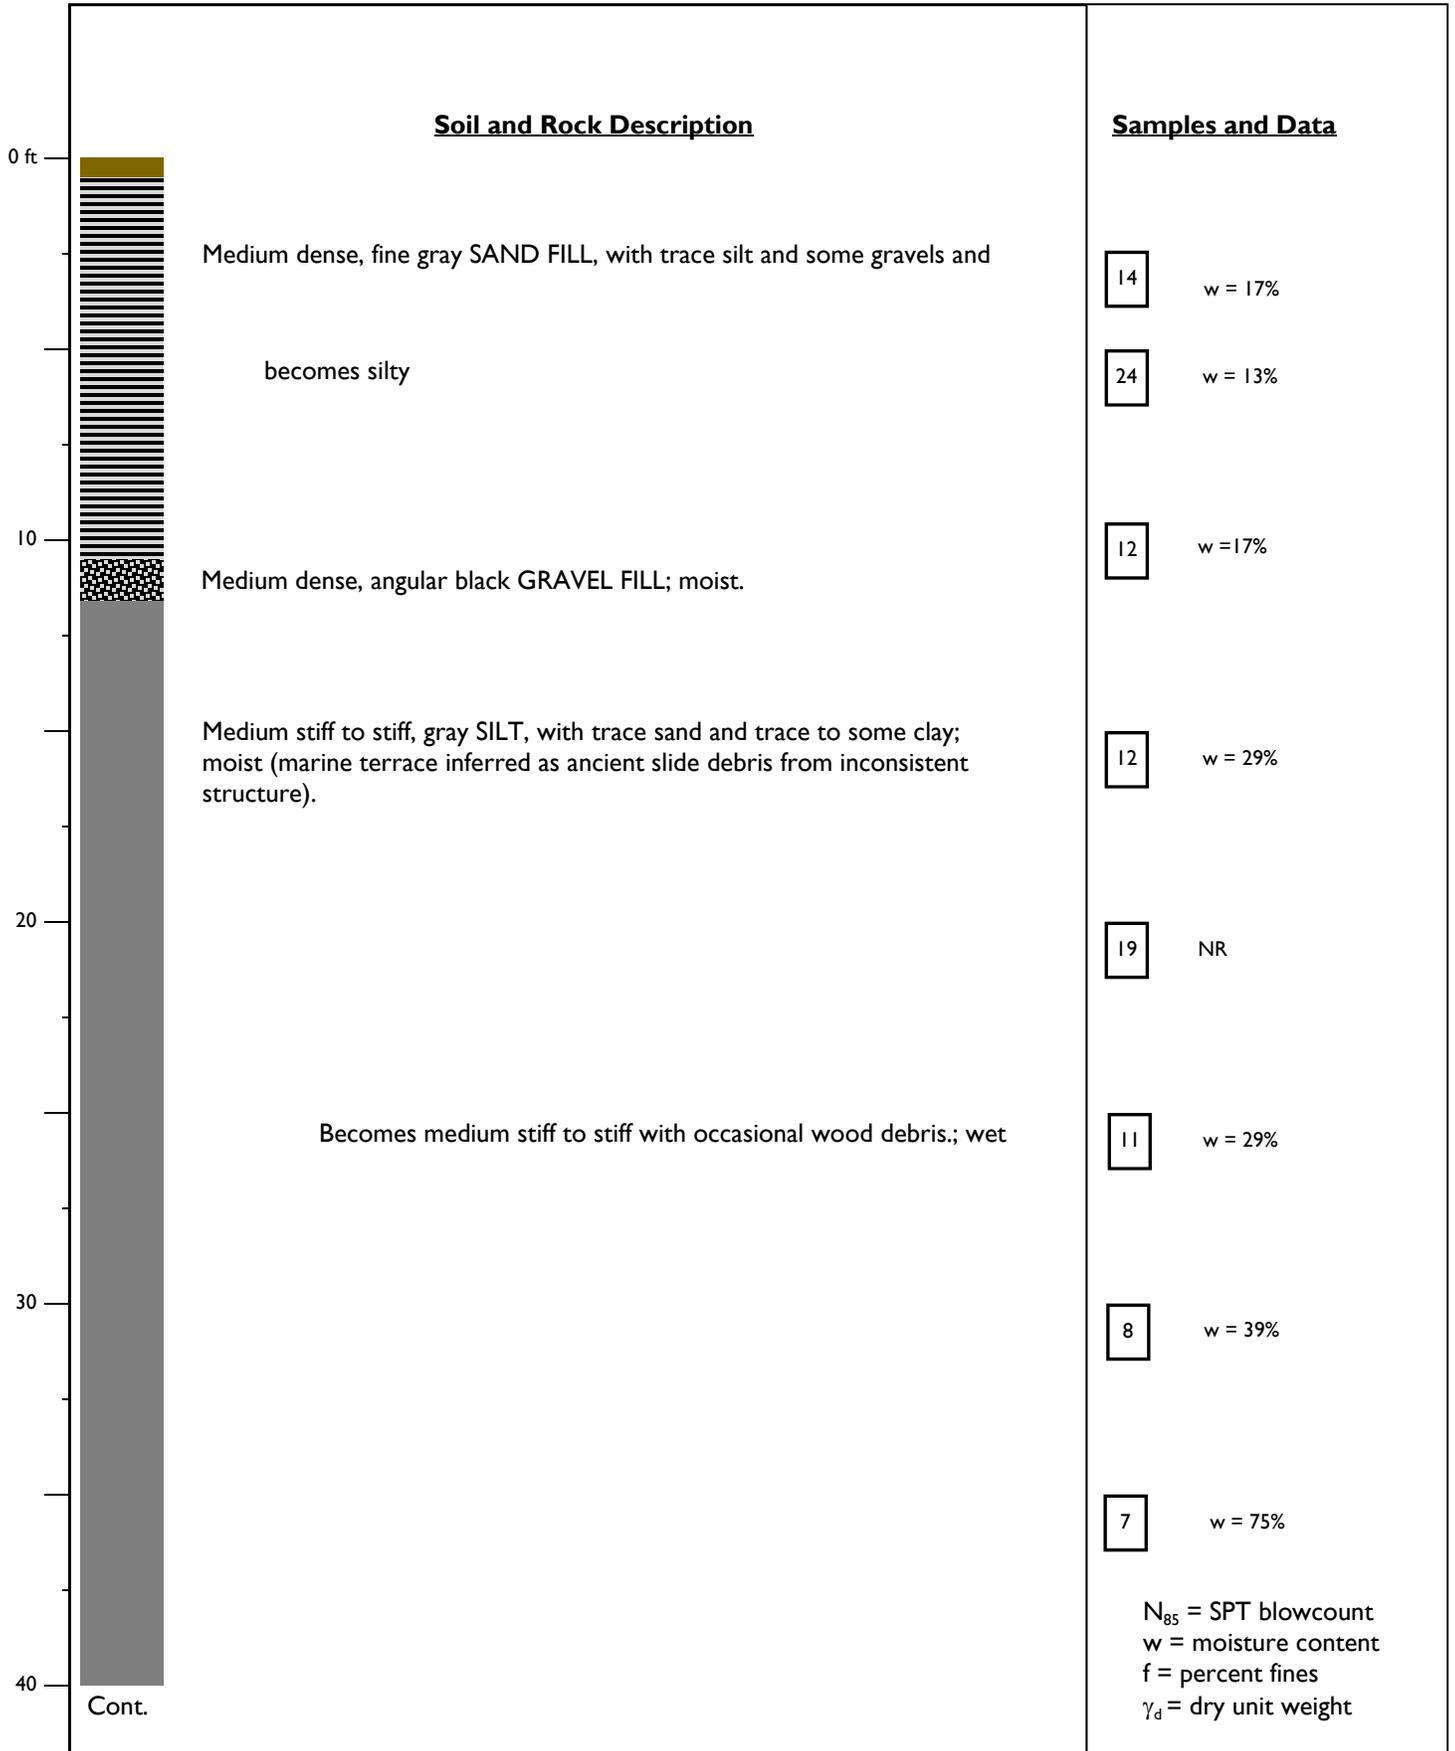
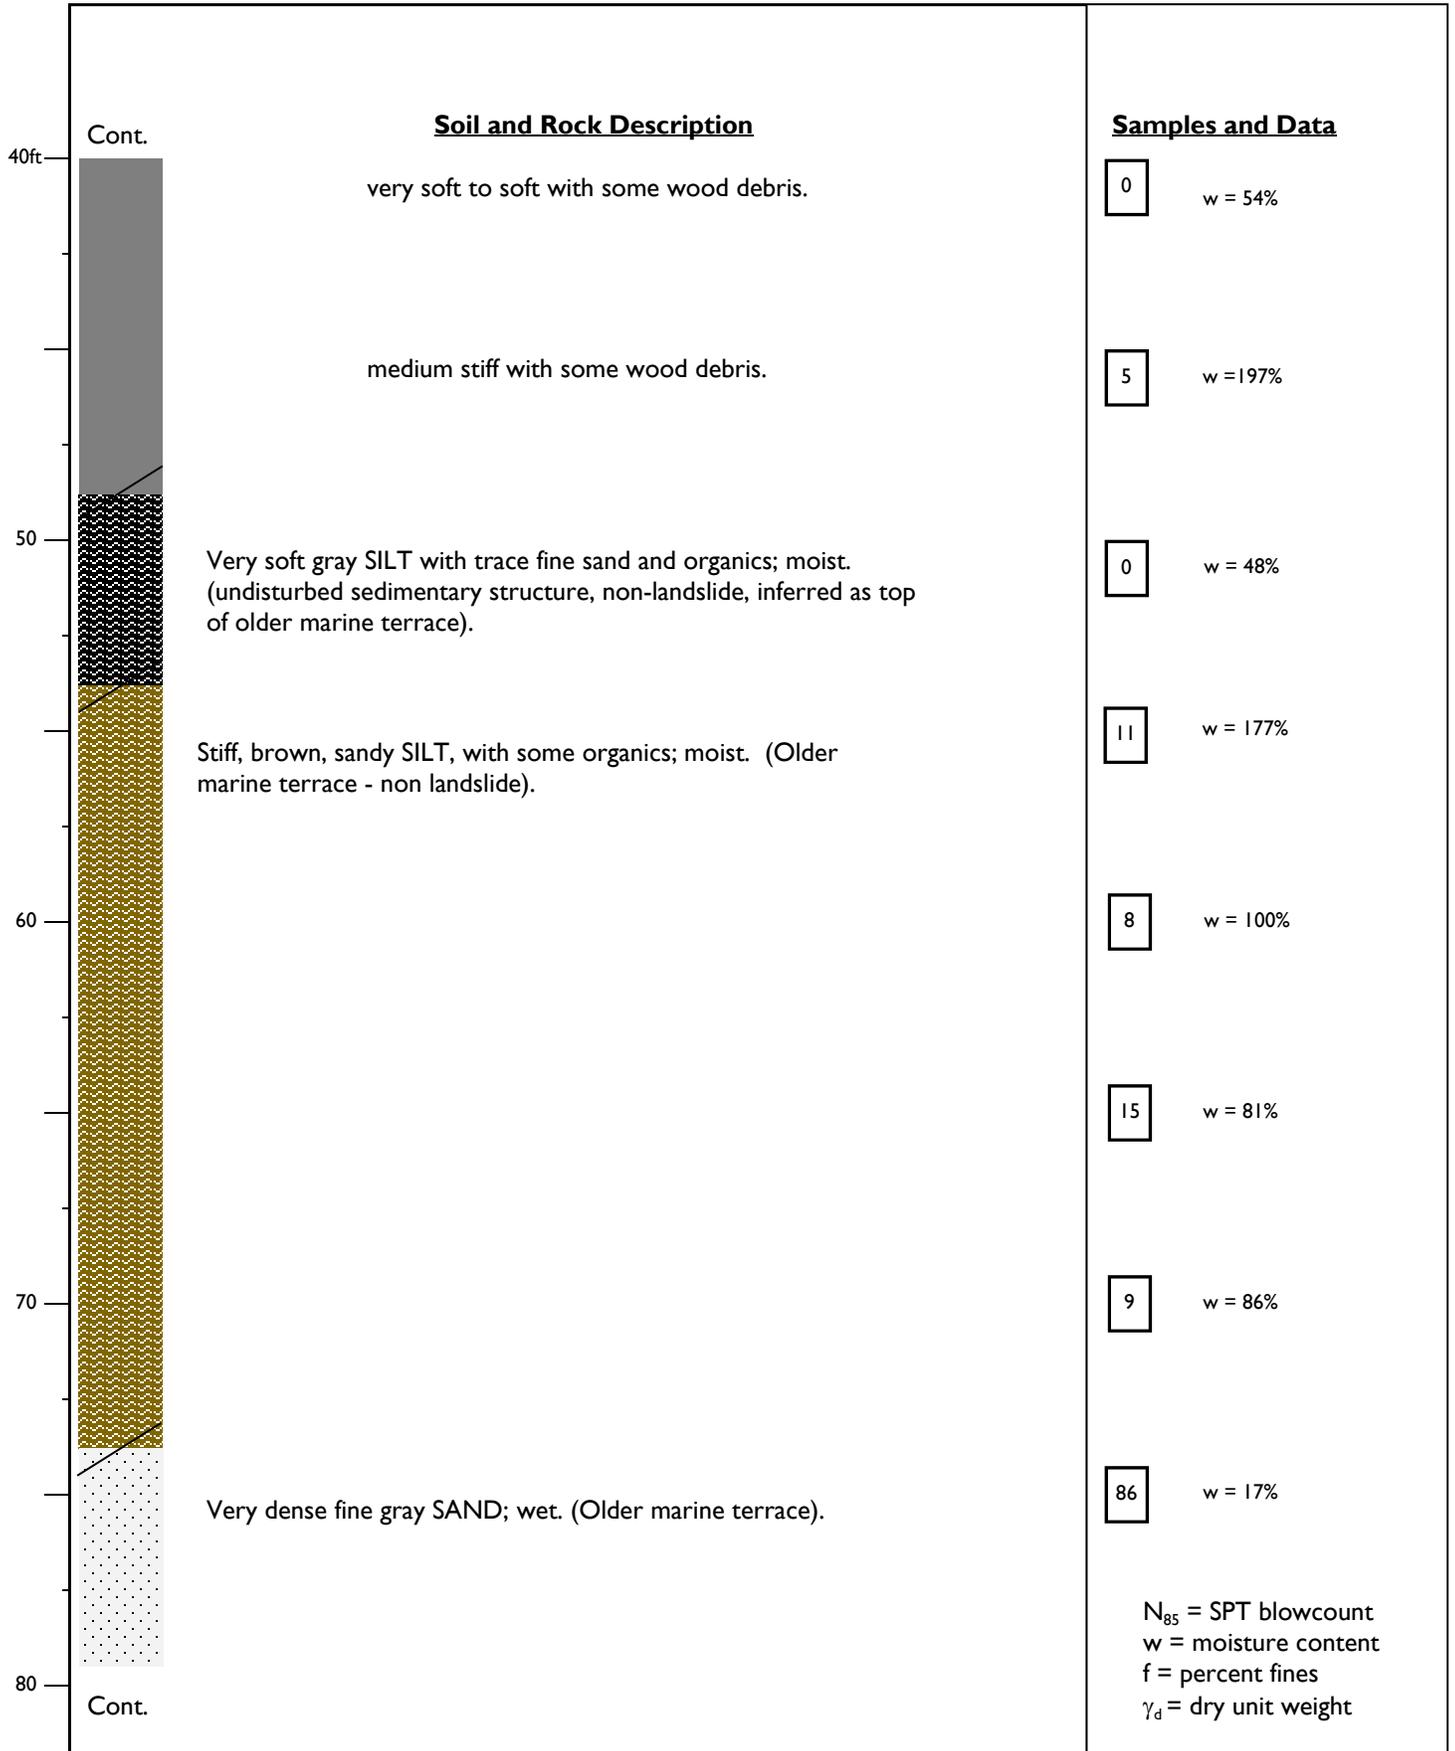
<p>80</p> <p>90</p> <p>80</p>	<p>Cont.</p> <p style="text-align: center;"><u>Soil and Rock Description</u></p>

<p>Hard, RH-3, little weathered, moderately fractured dark gray/black BASALT</p> <p>Tricone bit advanced roughly 6 feet per hour.</p> <p>NOTES: Boring completed to 100 feet on Sep 8, 2023. Backfilled with bentonite chips.</p>	<p style="text-align: center;"><u>Samples and Data</u></p> <p>50/5" w = 18%</p> <p>50/0"</p> <p>N₈₅ = SPT blowcount w = moisture content f = percent fines γ_d = dry unit weight</p>
-------------------------------	--	--

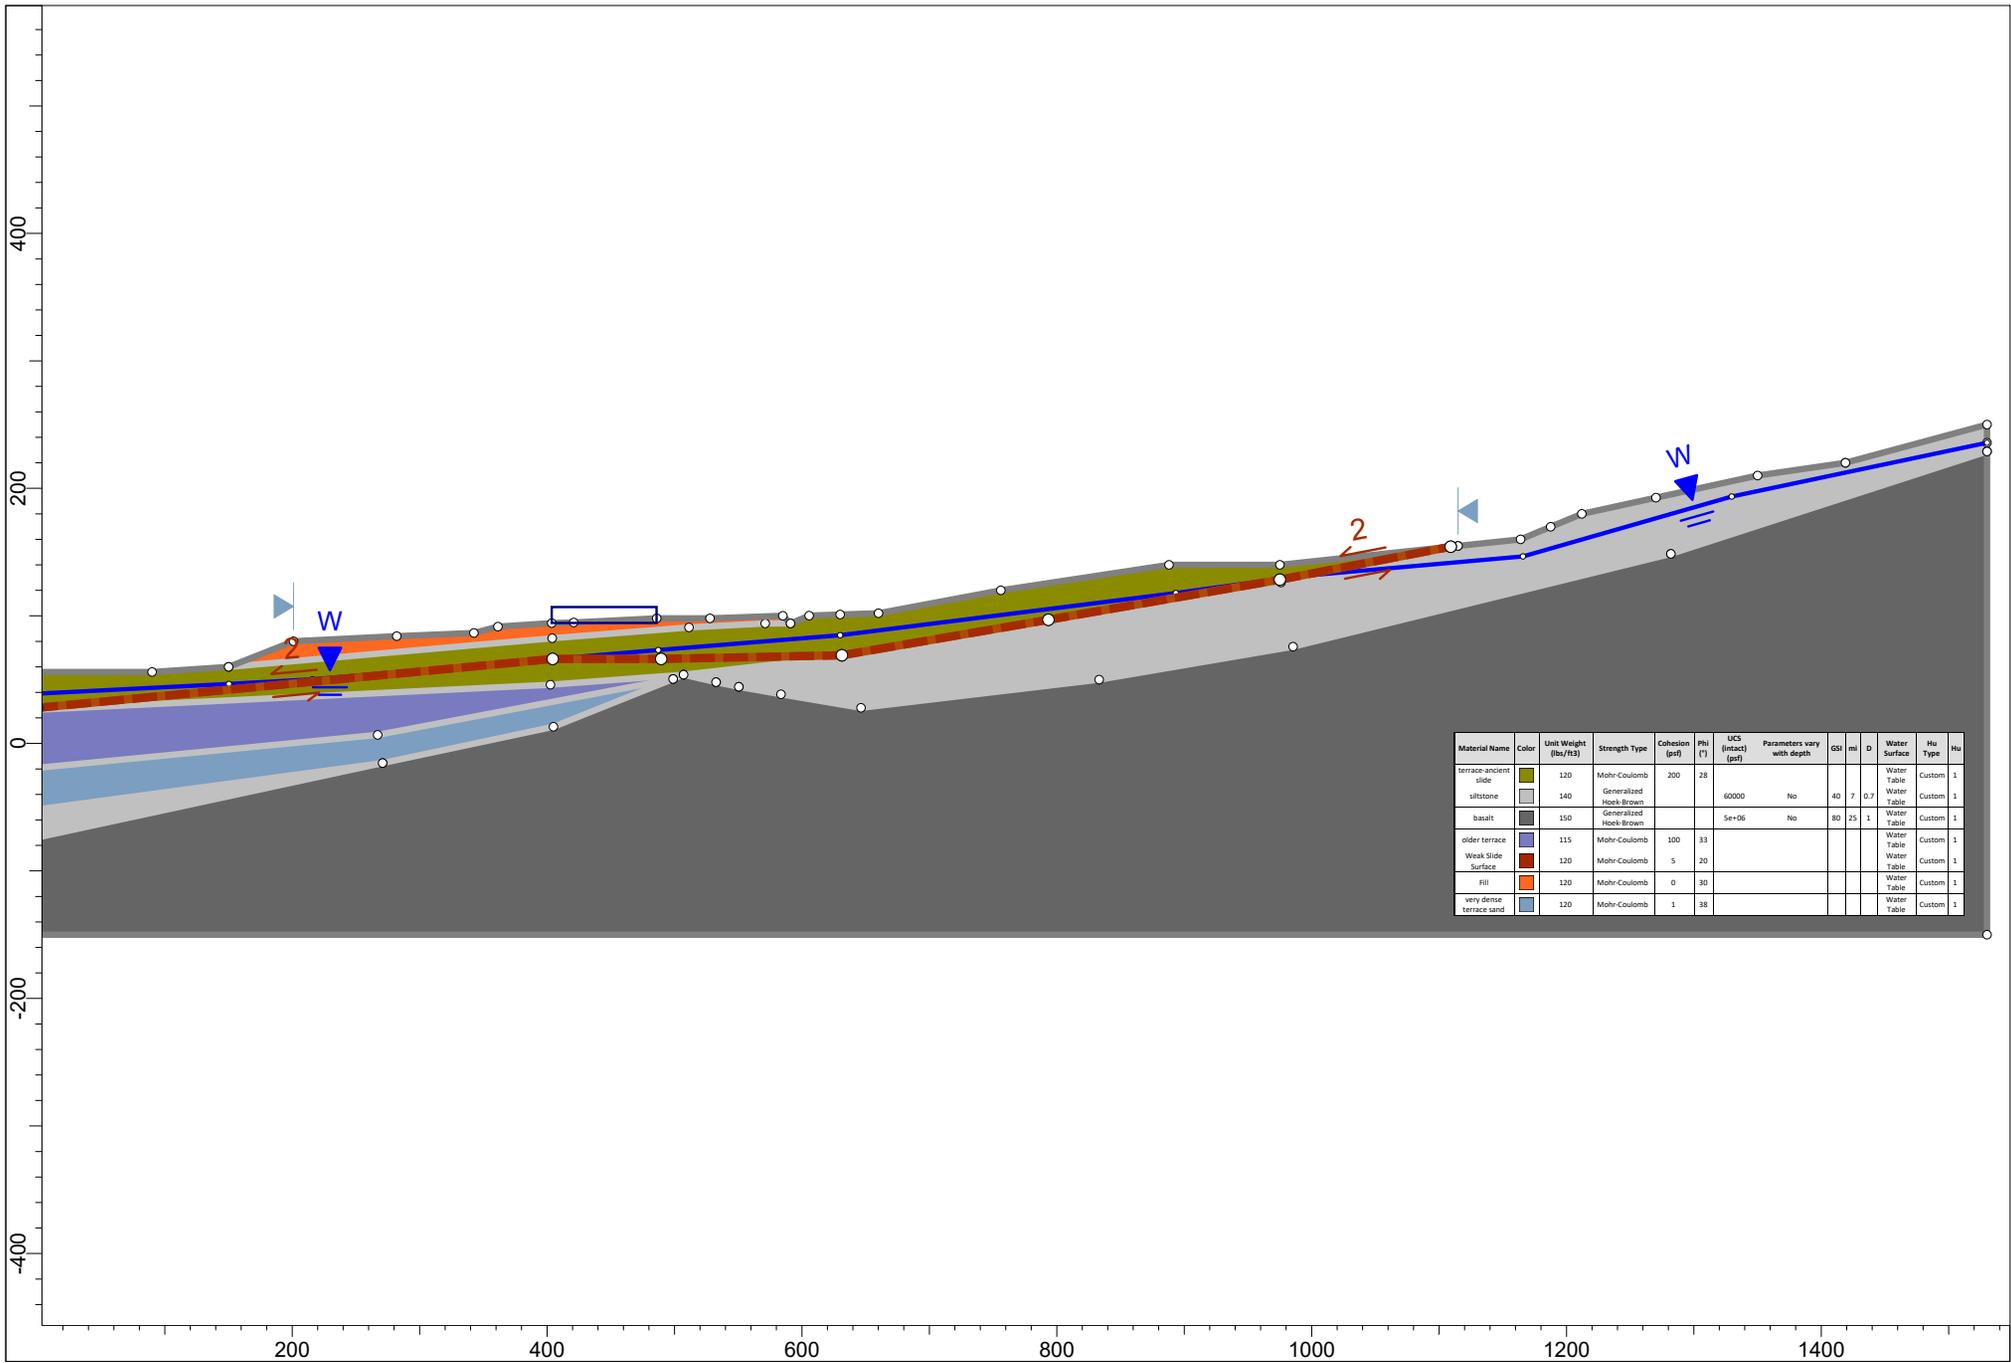
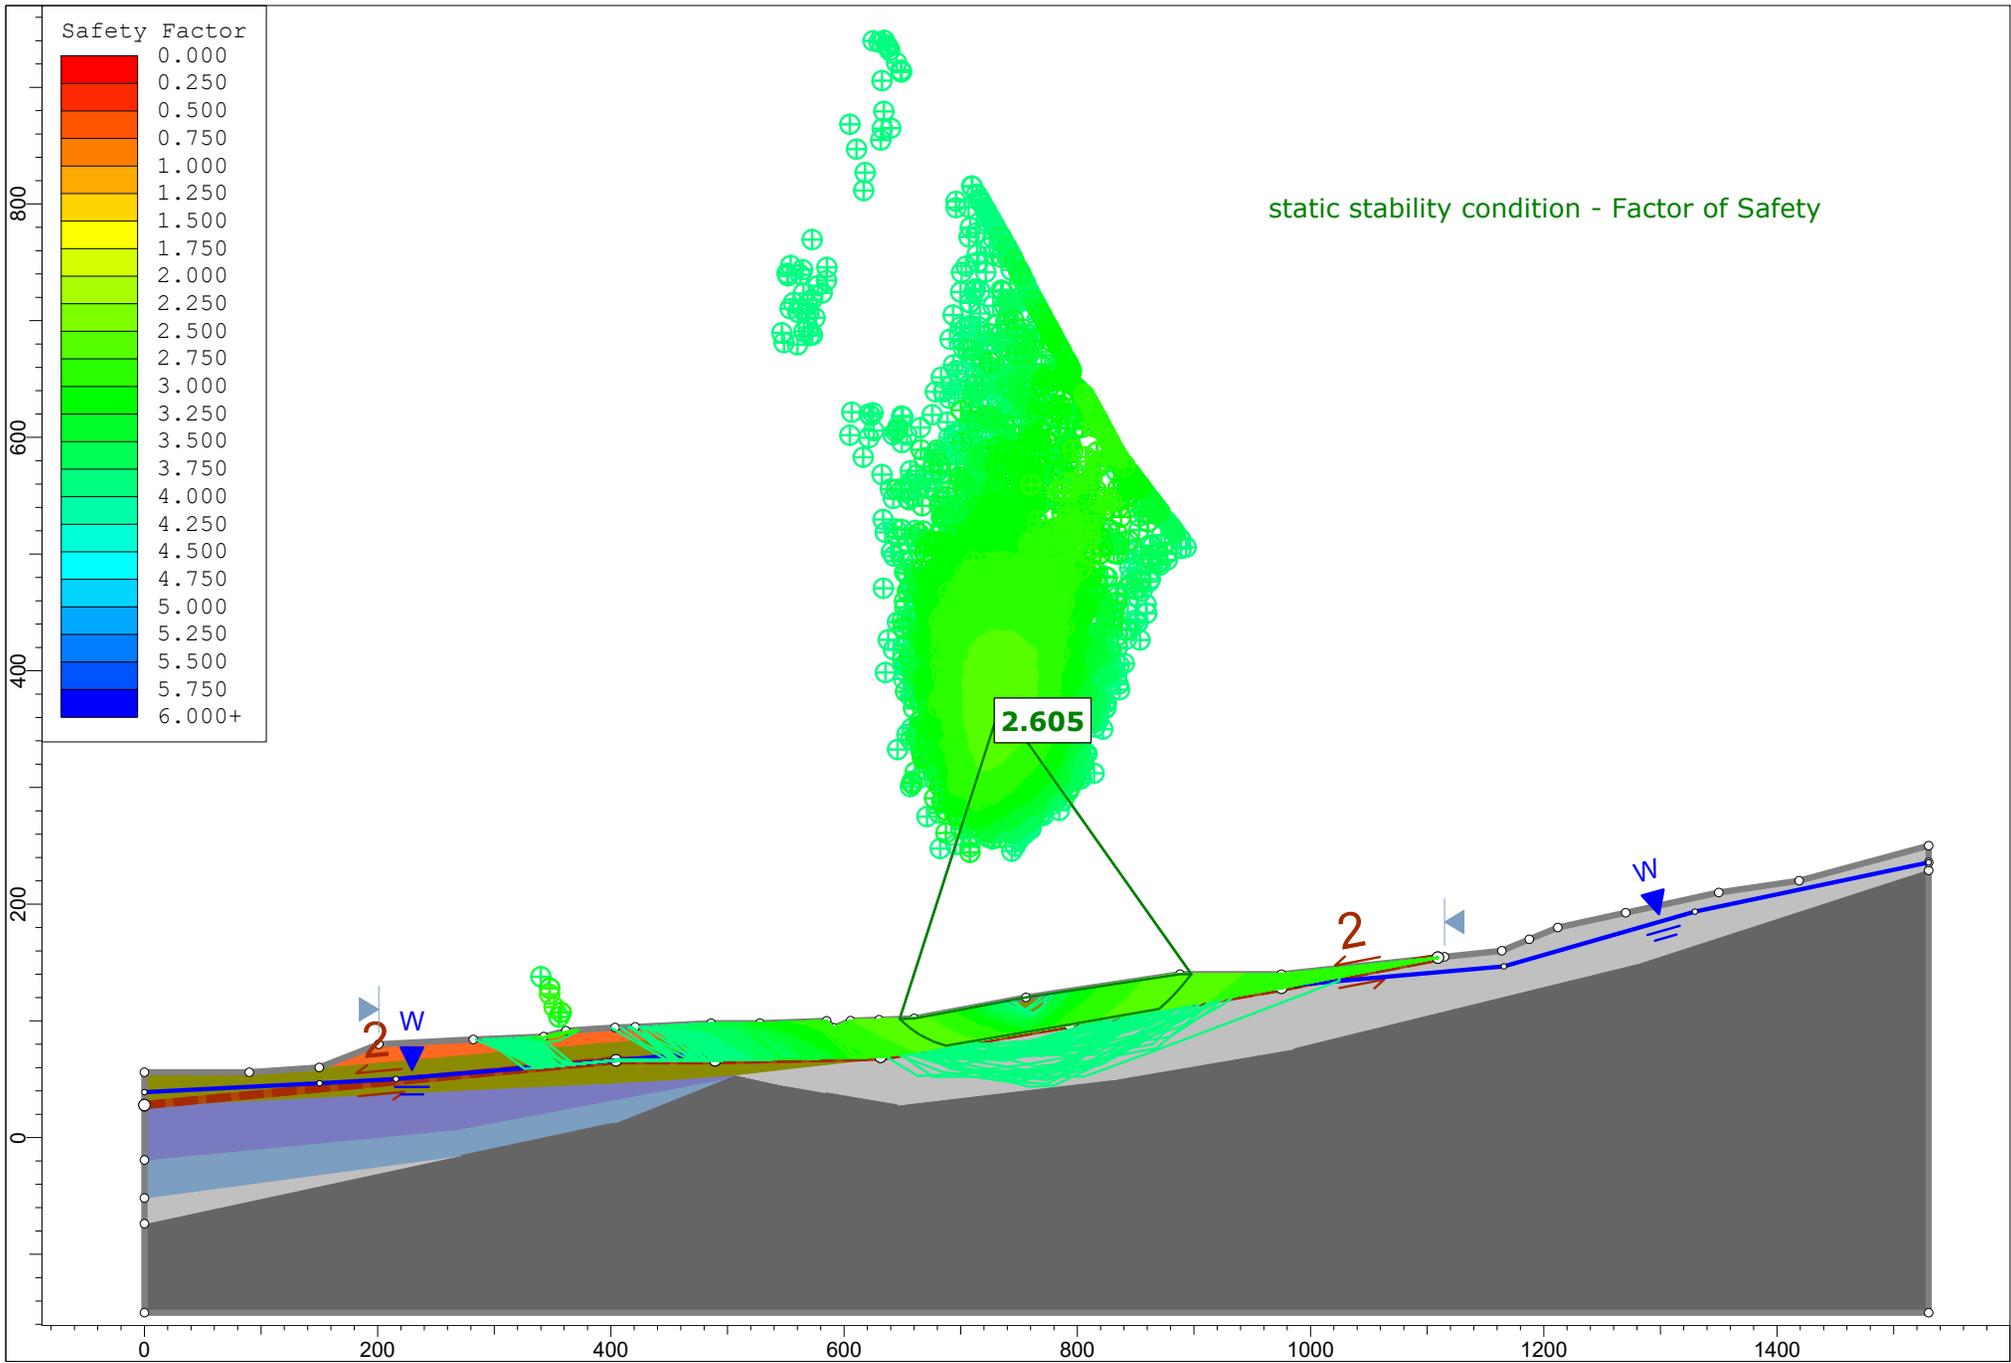
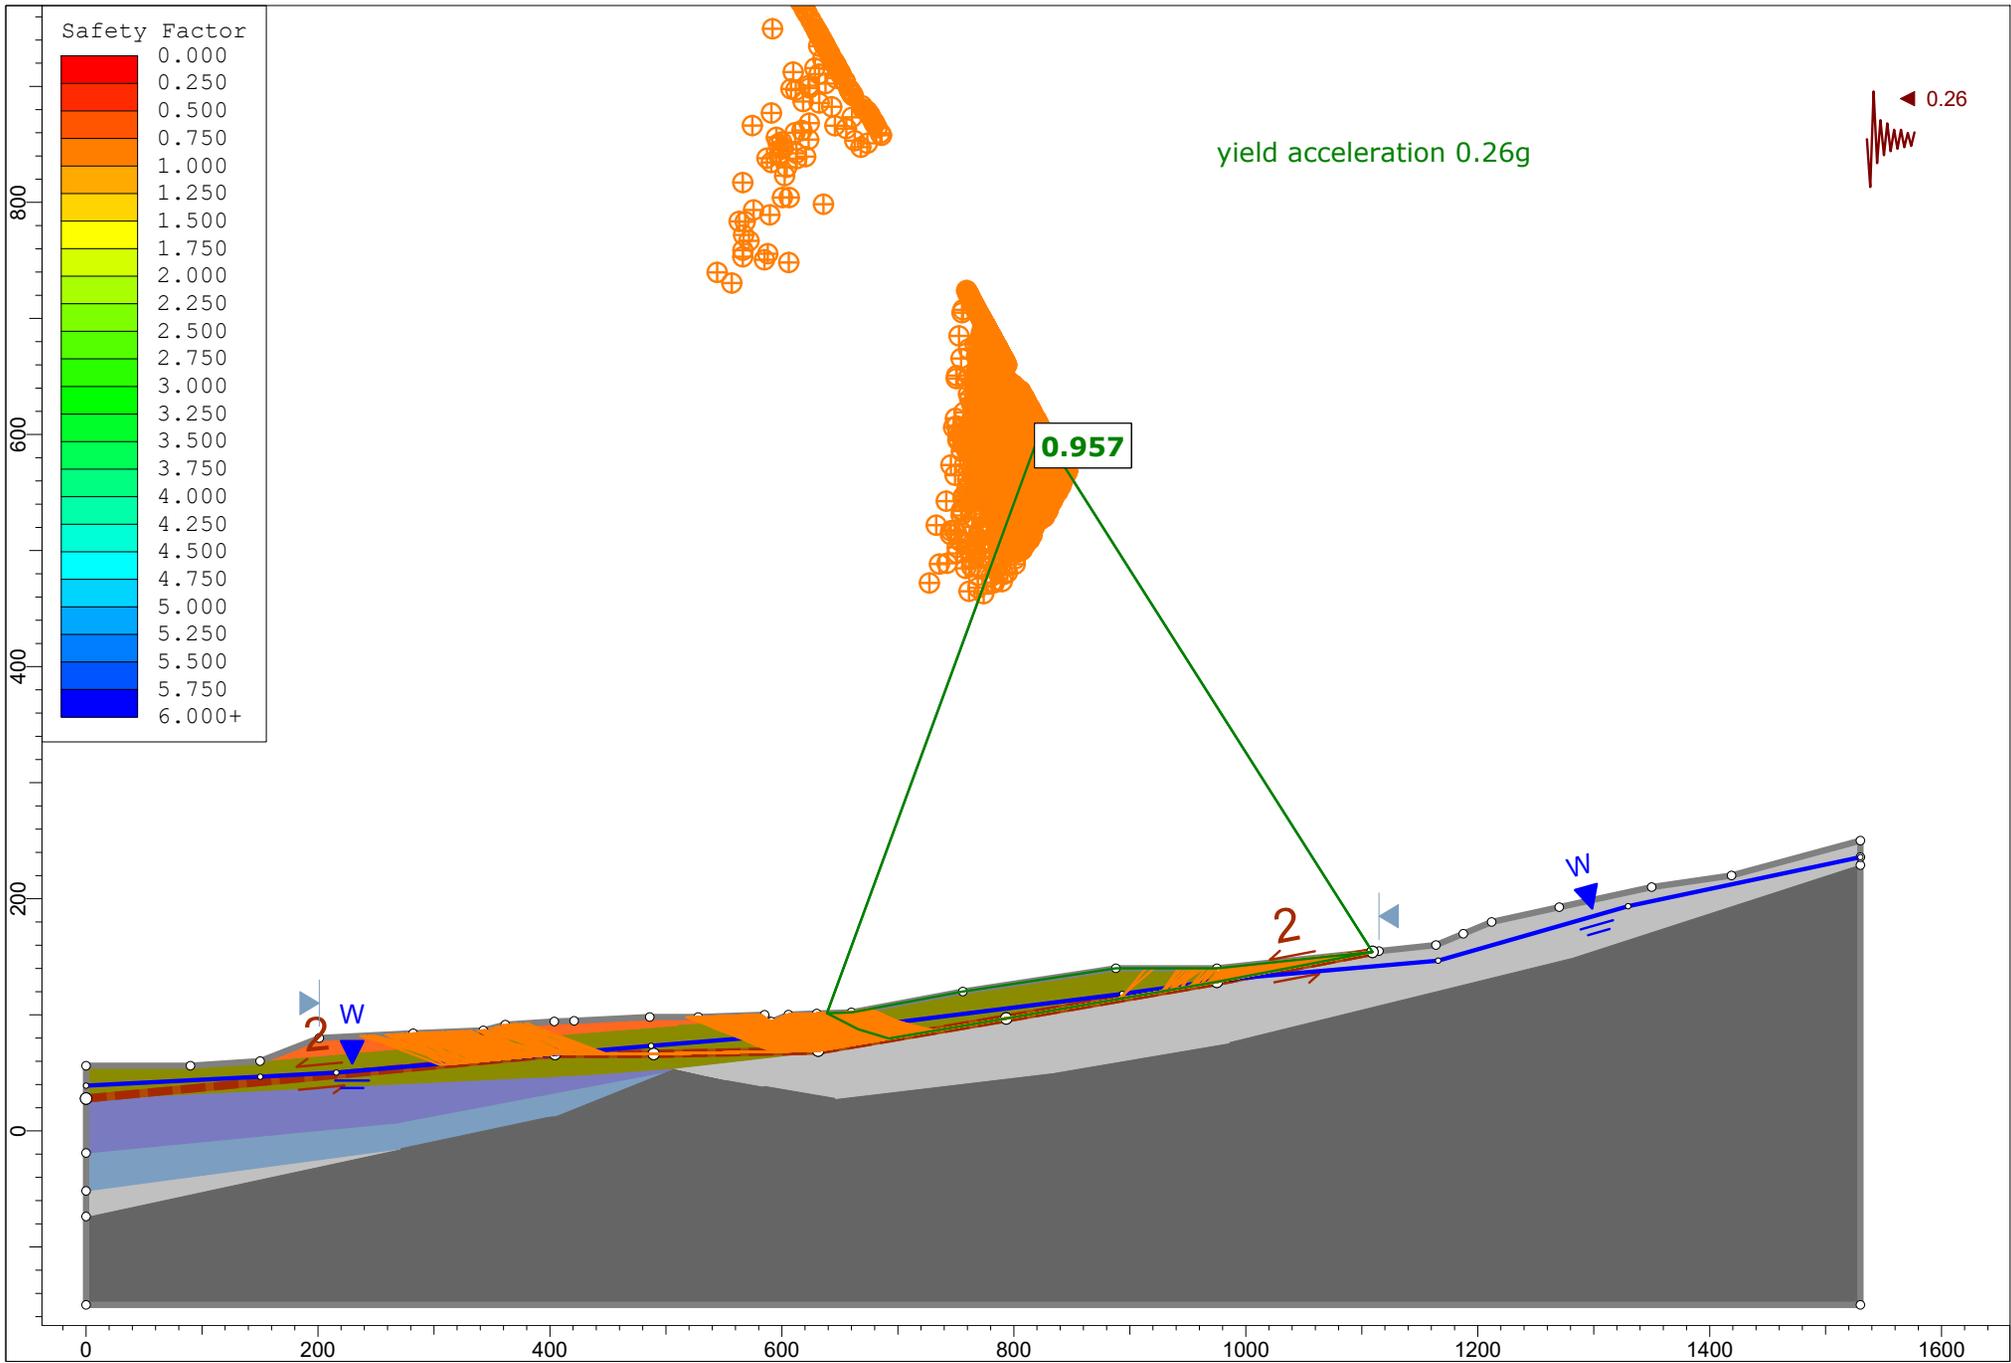
STABILITY SECTIONS

Section A-A 0p26g weak surface at spt0.slm

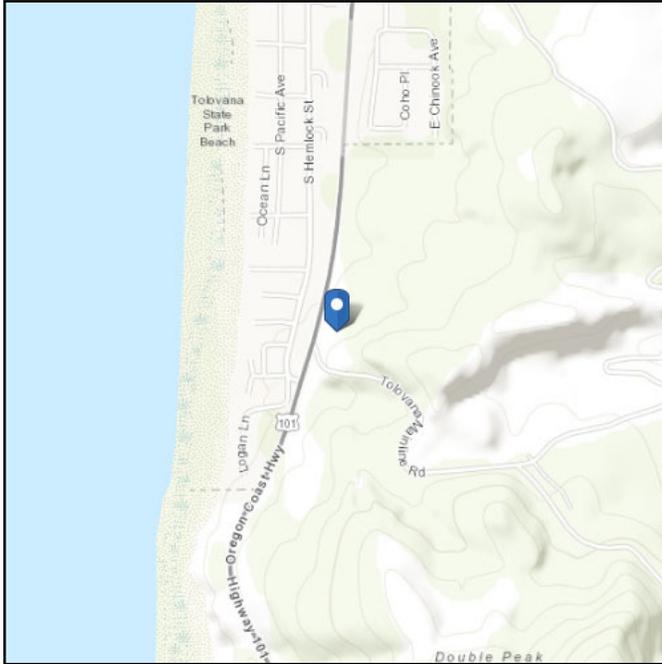
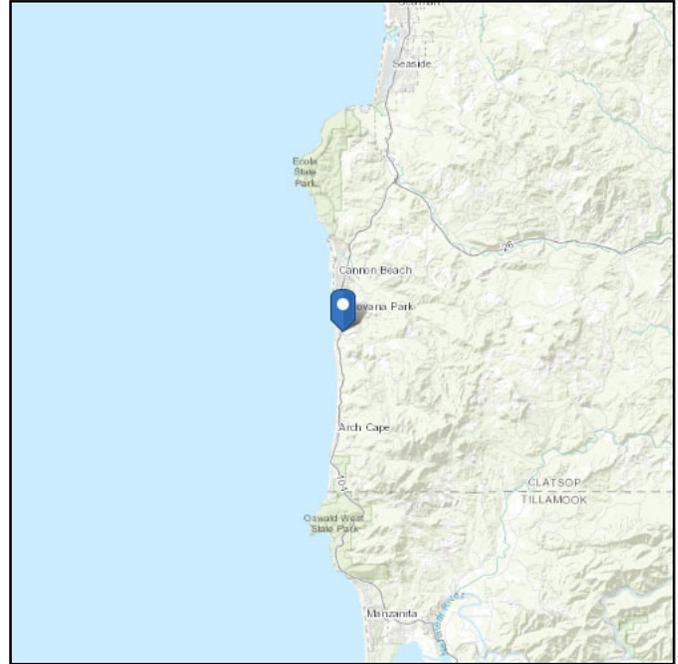
Standard: ASCE/SEI 7-16
Risk Category: IV
Soil Class: D - Stiff Soil

Latitude: 45.86268
Longitude: -123.958819
Elevation: 103.74040760446984 ft
(NAVD 88)

Site Soil Class: D - Stiff Soil
